ANDREW WARING
ASSOCIATES

**WW11 SITES IN THE
NEW FOREST NATIONAL PARK AUTHORITY
STRUCTURAL SURVEY REPORTS**

**JOB NO. 6706 – REPORTS
DATE SEPTEMBER 2013**

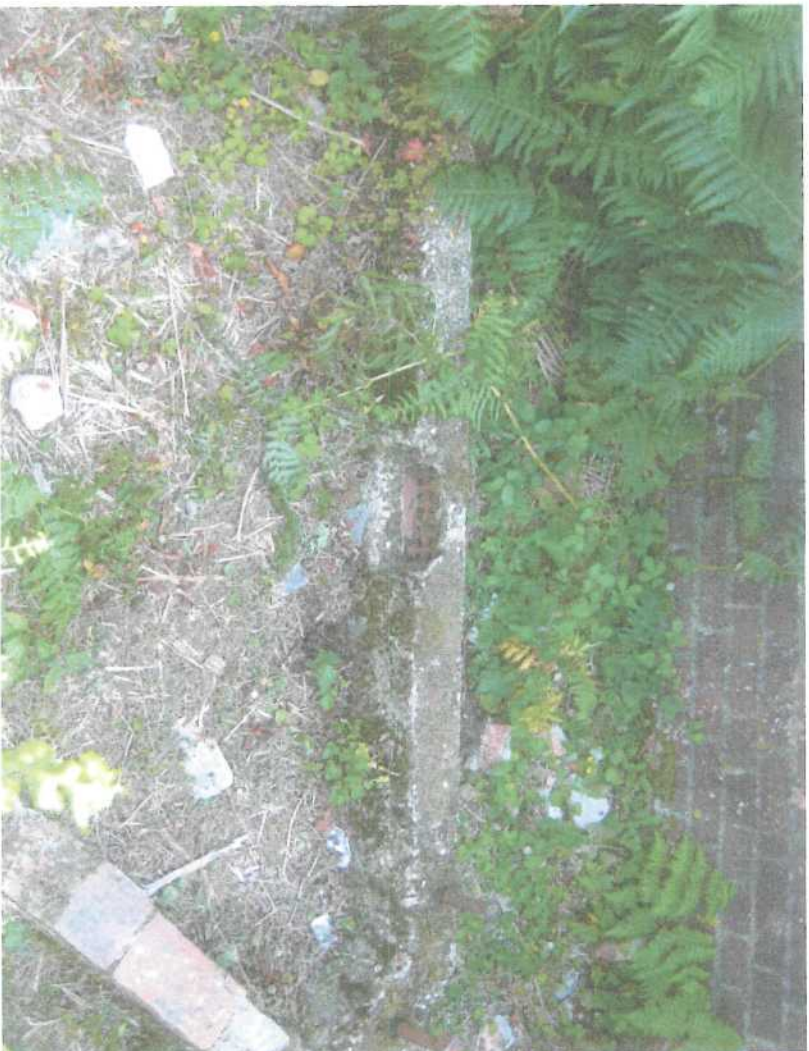
Photo 1

The main structure comprises one octagonal brick enclosure truncated on one side to give access. The perimeter wall is of 1½ brick construction some 1.9m high. Within the perimeter wall there is a ground level construction comprising an octagonal perimeter concrete wall some 150mm above ground level, and a pair of parallel brickwork cross-walls 225mm above ground. Two holding down bolts are positioned at each corner of the octagonal plinth. (photo 1).

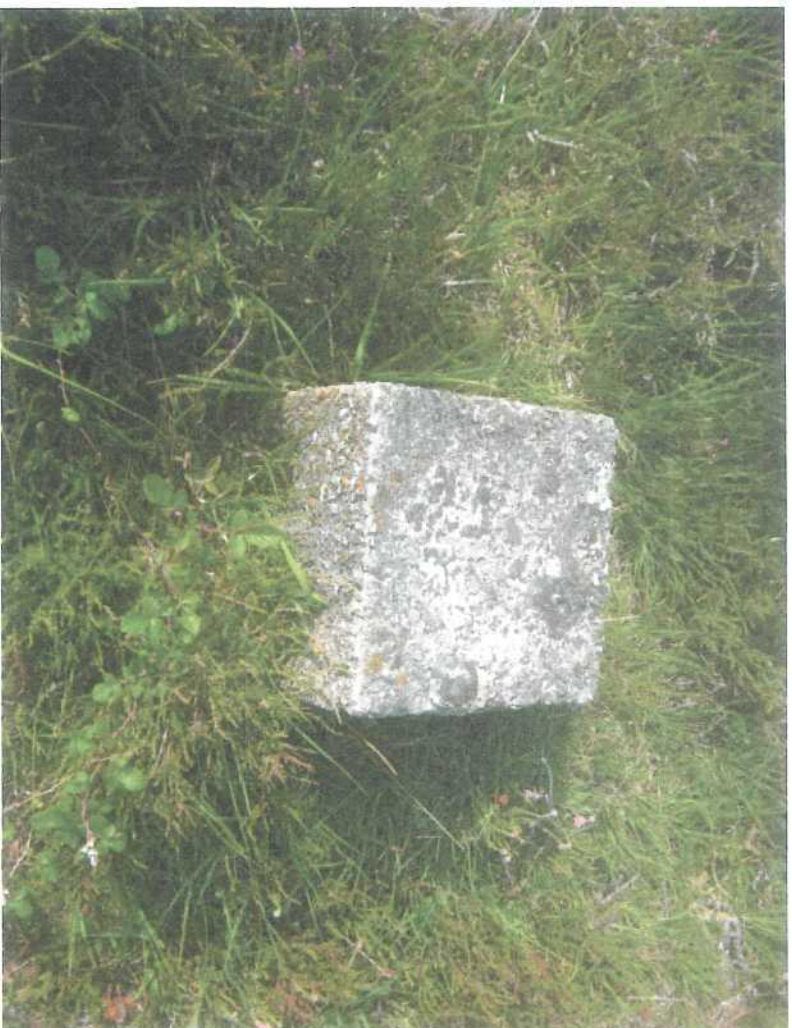
Photo 2

Arranged radially around the main structure are a series of concrete plinths. These plinths are some 10m away and sited on the corner and mid face lines of the octagon. These plinths remain in 11 locations and are some 12" square in plan, 24" long bedded into the ground; they do not have a common top level. (photo 2).

The concrete blocks forming the external radial plinths all appear sound. Most remain in-situ but one has been uprooted and, assuming there were originally 16 in total, 5 have now been lost, with 11 remaining in situ.

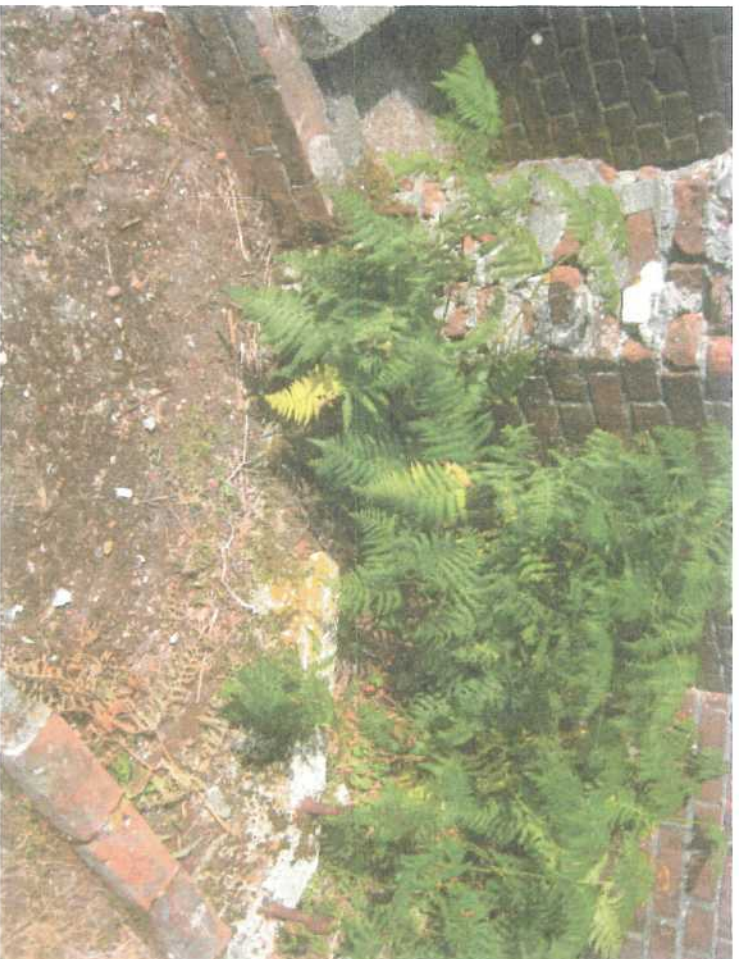
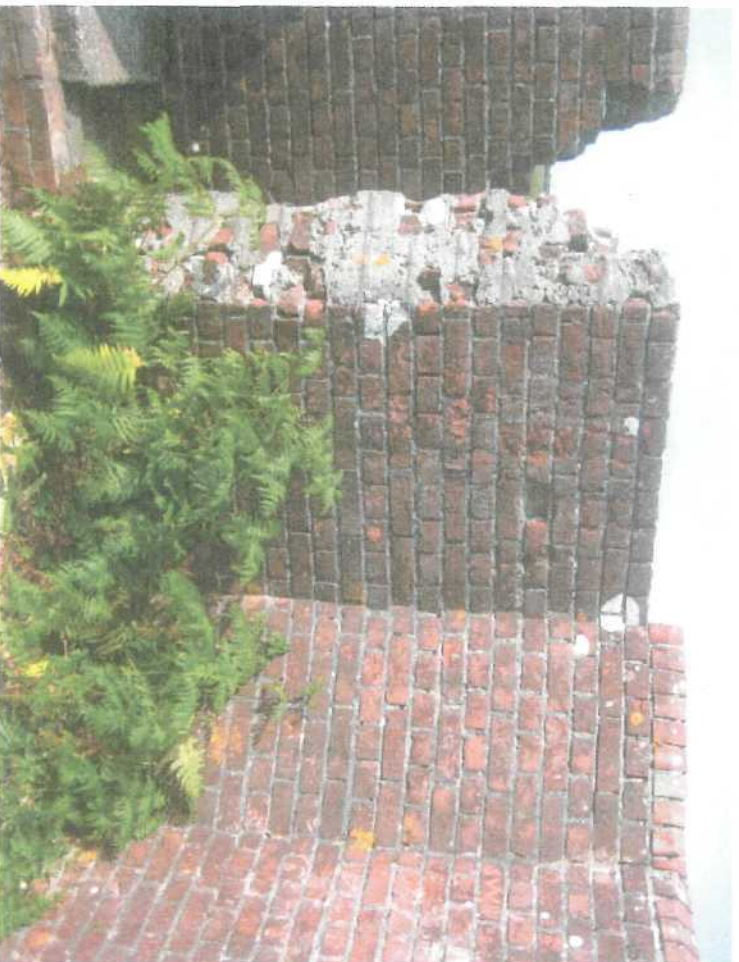
On the left hand side of the entrance, the wall capping is lost and the vertical edge is rather ragged (photos 3 & 4).

Minor repairs should be undertaken to the brickwork containing wall including rebuilding the small section lost by the entrance and the capping.

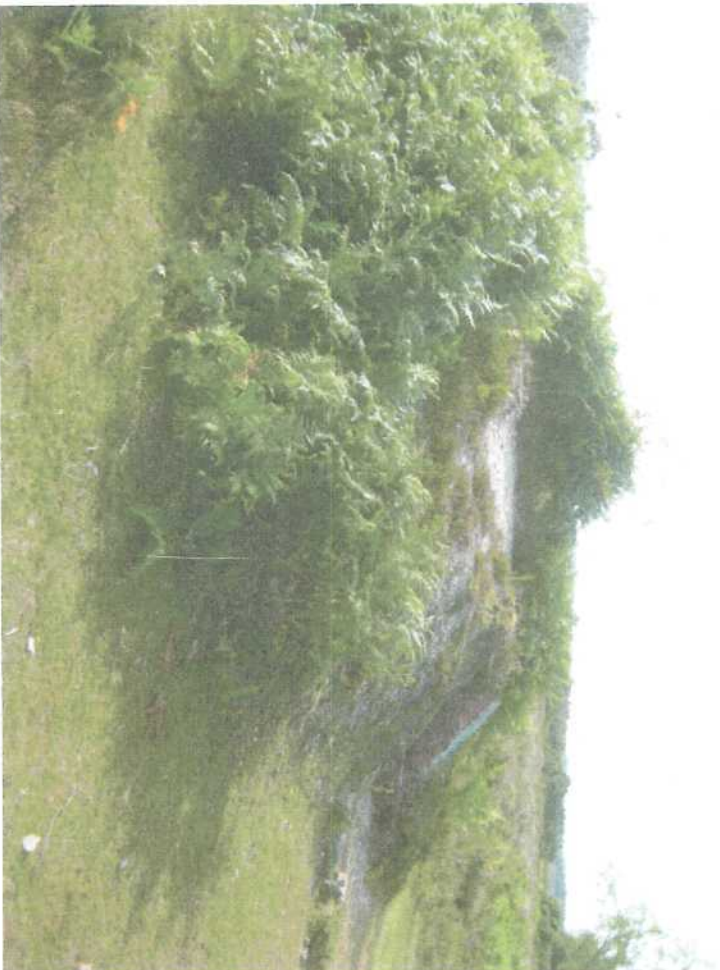
Photo 1

The primary surviving structure is a bunker. The bunker is formed of load bearing brickwork with an internal render finish. The roof slab is of concrete cast in-situ. Earth bunding surrounds the bunker and partially overtops the roof slab. (photo 1)

The bunker should be emptied of debris to allow a final inspection.

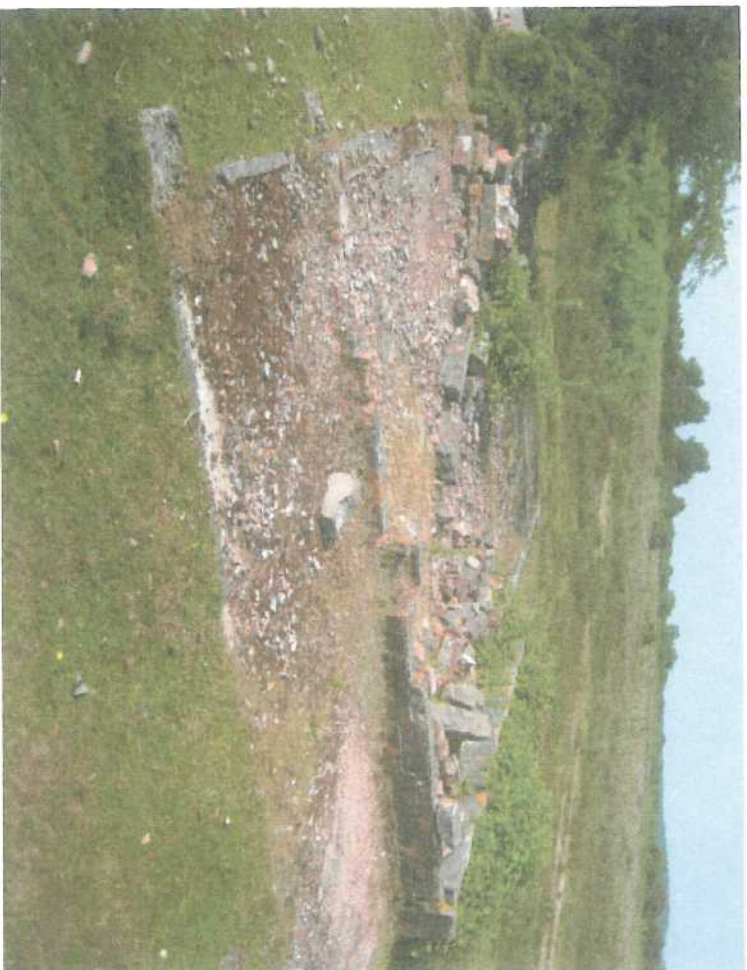
Photo 2

In close proximity to the bunker, there are the remains of a brick building some 3.2 x 6.4m in plan. All that remains is the ground slab and a few courses of brickwork to parts of the perimeter, and brick rubble. (photo 2)

The original adjacent building appears to have been of simple brickwork form with concrete ground slab. Most of the brickwork has been lost with only the lower few courses remaining in some areas. The concrete slab appears in reasonable order.

The adjacent building slab should be left. The low level brick walls can remain and could be potentially reinstated to show the original form.

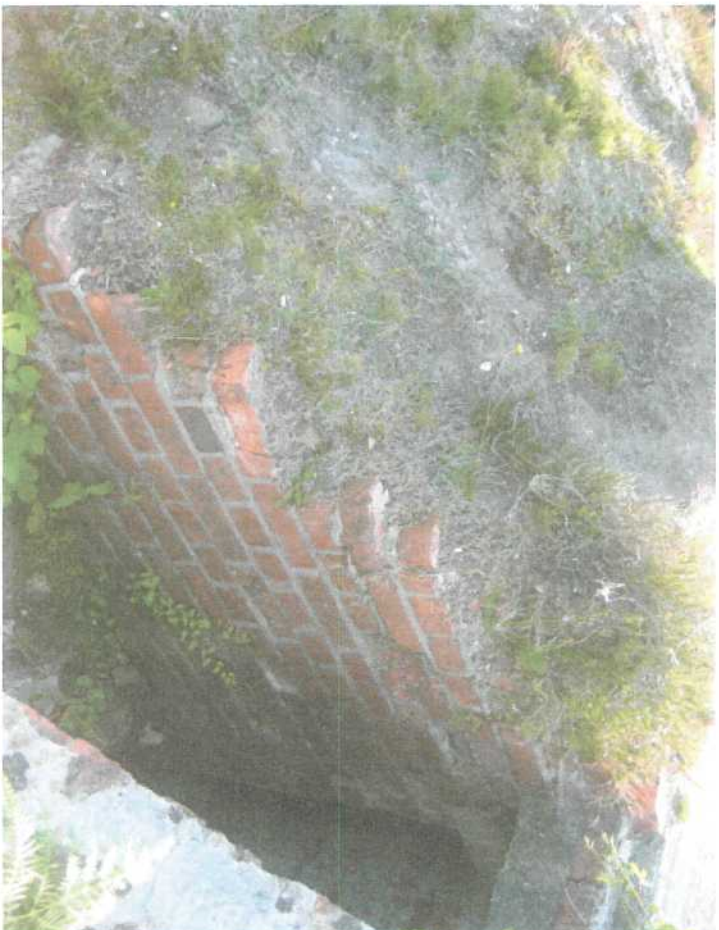
Photo 3

The bunker is entered from the eastern side. Brick walls, 9" thick, enclose an entrance with steps down. This brickwork is in good order, although some bricks have been lost from the coping. (photo 3).

Minor brickwork repairs should be undertaken, particularly to the entrance area.

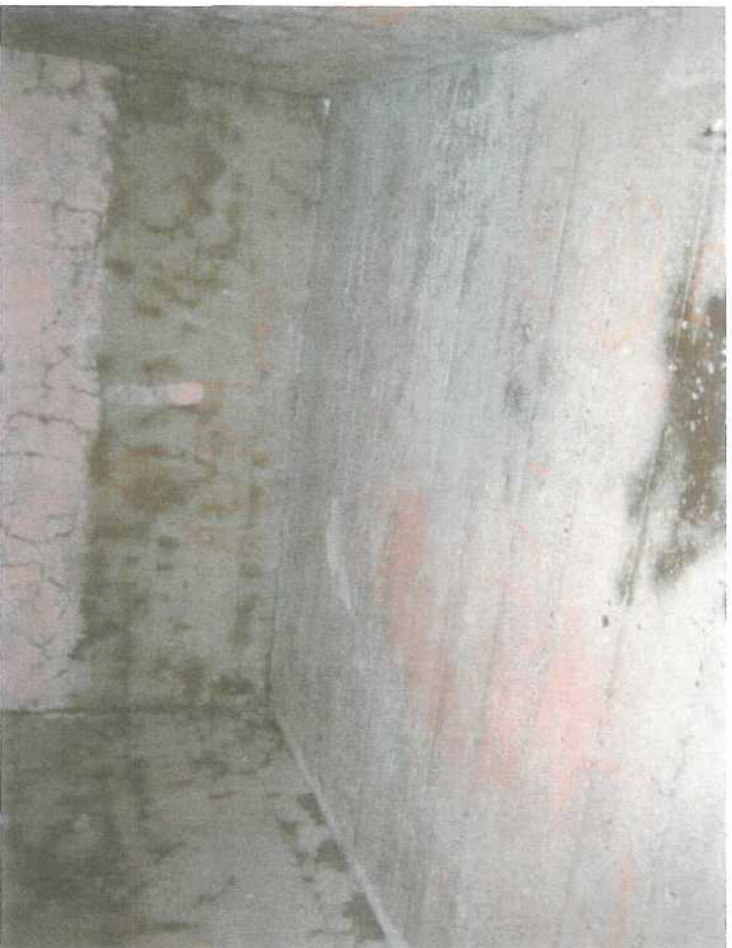
Photo 4

The bunker itself is also formed of brickwork perimeter walls which appear in good structural condition. The bunker walls are rendered; some of the render is crazed with small areas having detached. There is widespread surface algae. (photo 4)

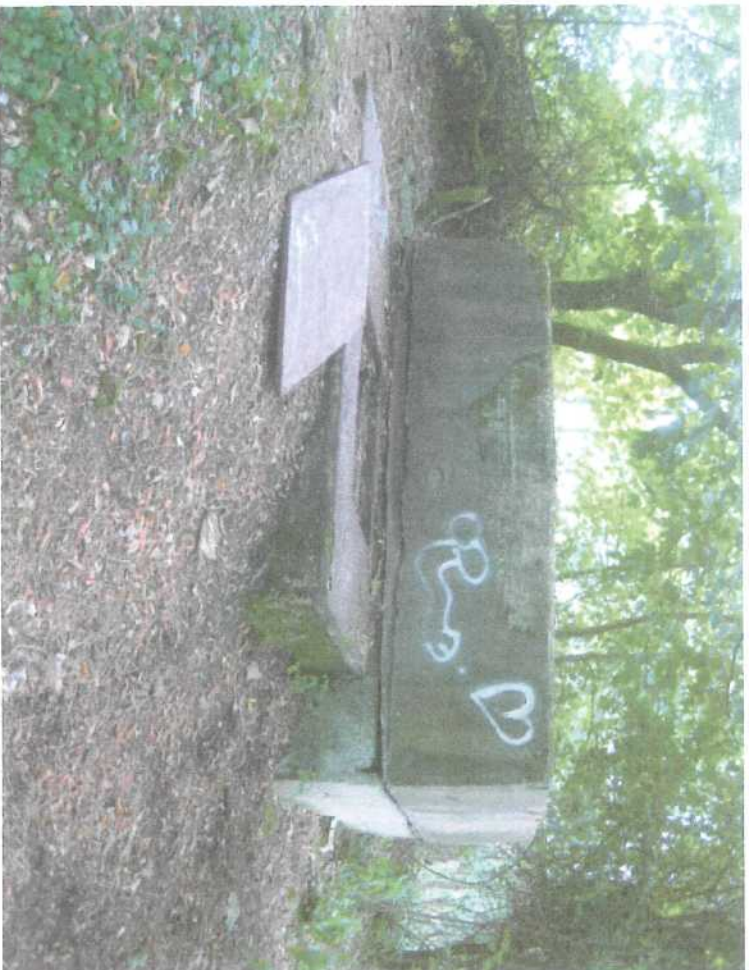
Photo 2

The Battle HQ takes the form of an underground bunker with two above ground 'turrets'. There is also an entrance from the south via a pathway and steps down into the bunker. (photo 1). There is an escape hatch from the northern side of the complex. (photo 2).

The escape hatch gives access to the bunker but the plywood cover needs replacement with a robust secure solution.

Provide secure entry gate and escape hatch cover to prevent vandalism

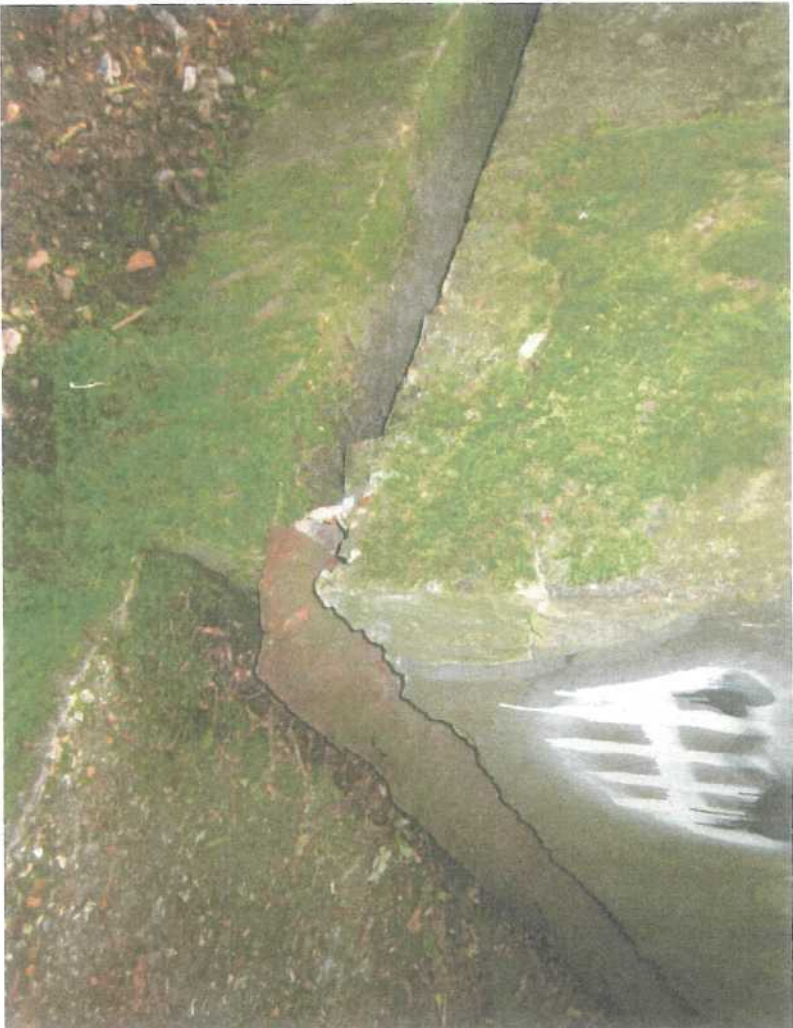
Photo 4

The southern turret and exposed roof are of concrete with a thin render skim. This render has been lost in a number of areas. The vision slit shows vestiges of a metal flashing but its form and purpose are now unclear. (photos 3 and 4). The concrete shows no undue sign of distress (photo 5).

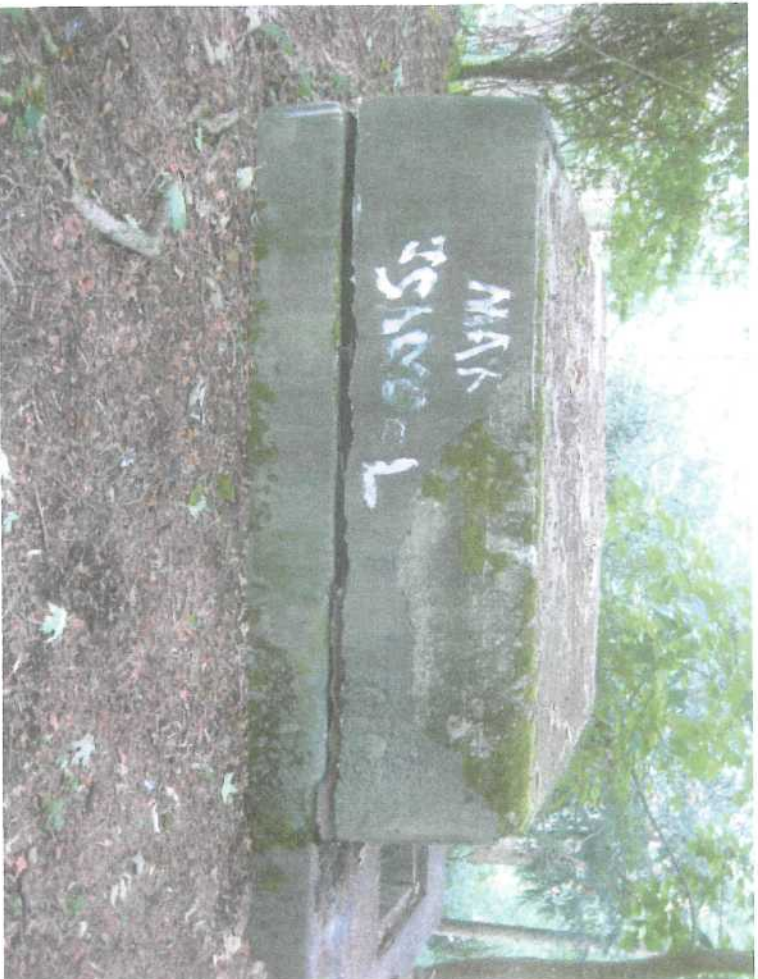
Photo 6

The northern turret is of the same construction as the southern, albeit that the vision slit is for the full perimeter. The concrete appears sound throughout although, as before, there is some loss of the render layer. (photo 6).

Investigate further external waterproofing render and repair/reinstate

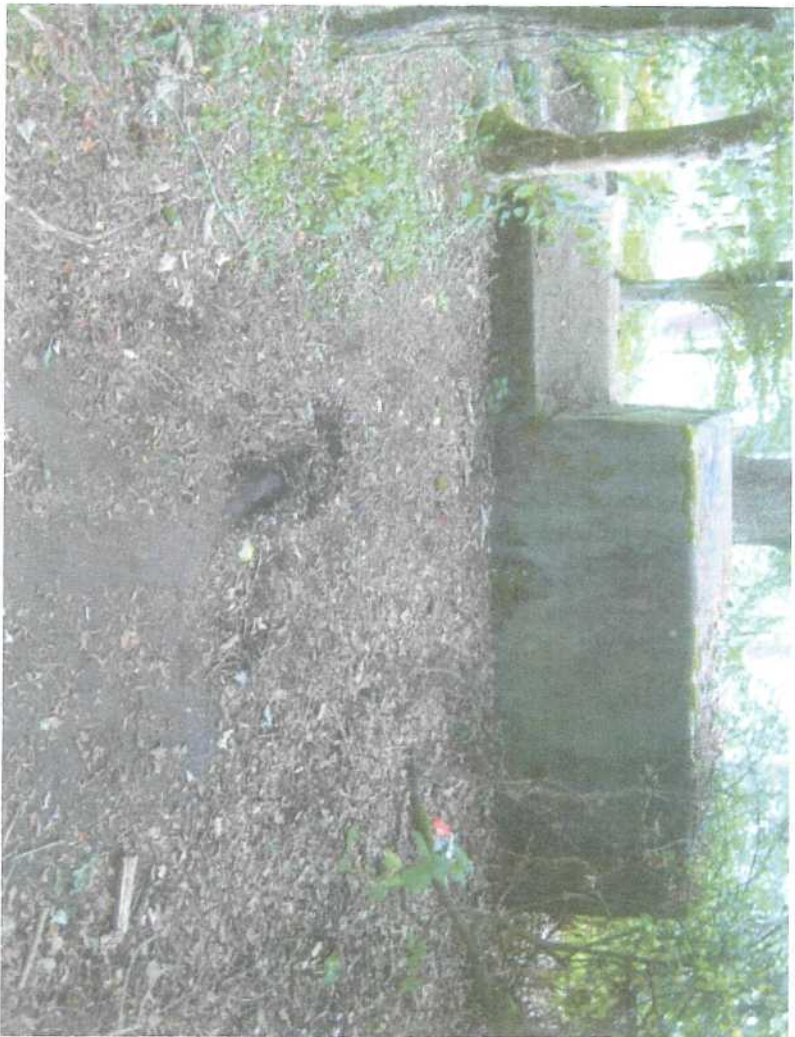
Photo 7

Removal of the shallow layer of ground between the turrets reveals the upper surface of the main bunker slab which is again protected by a thin layer of render. The small area exposed appears in good order (photo 7).

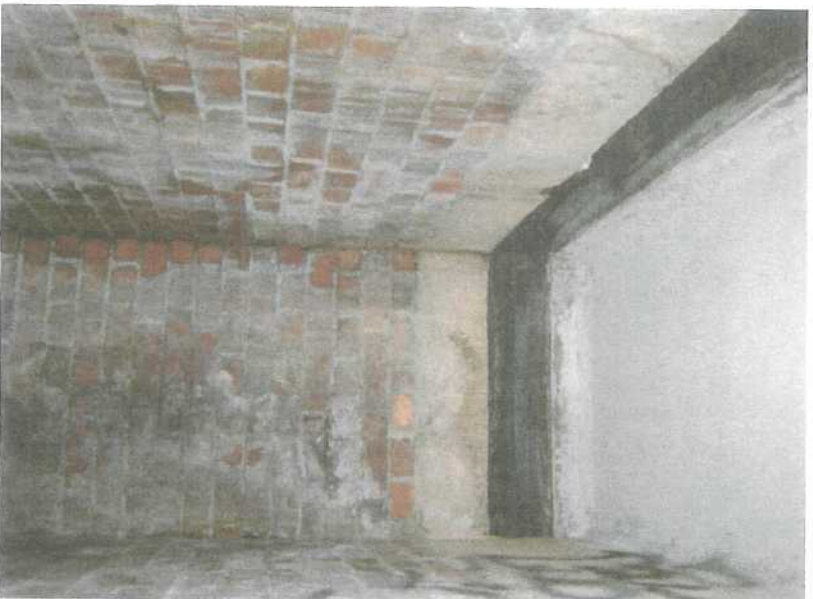
Photo 8

Steps lead up to the southern turret which is only some half the width visible above ground. There is a vision slit on 3 sides (photo 8). The brickwork walls and concrete floors are all in good order. The upper roof slab is supported on brickwork on its north side and on tapered steel I sections elsewhere. These sections are corroded and there is some damage to the concrete cill on which they sit as well as to the section itself. The concrete capping slab appears in good order.

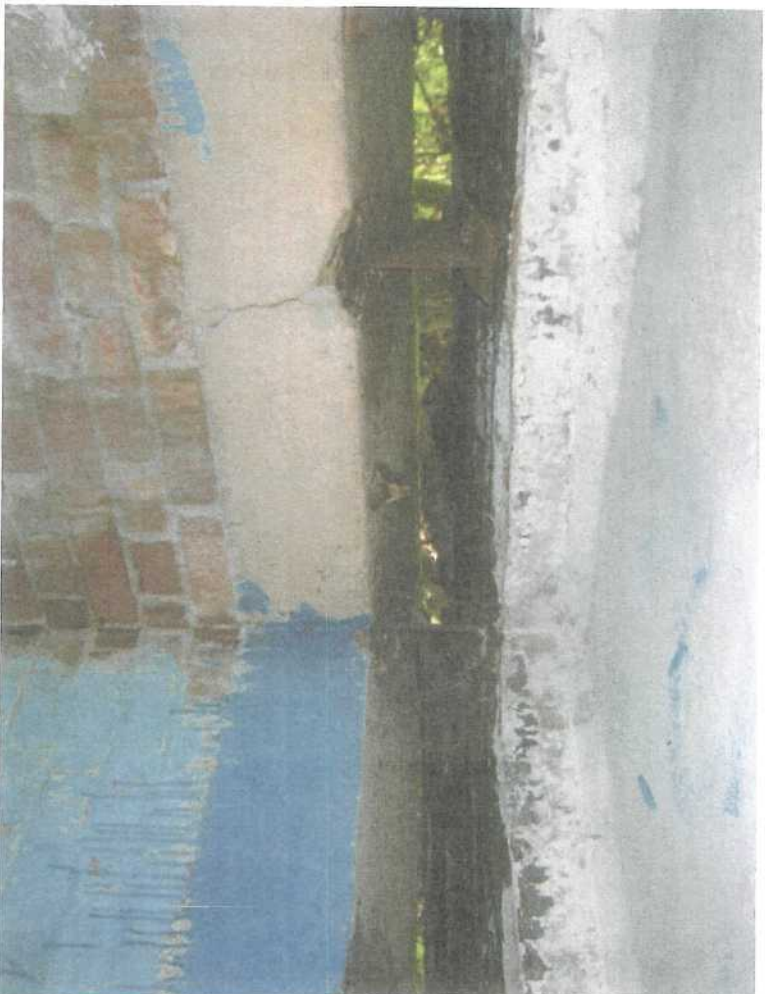
Photo 9

The upper roof slab is again of reinforced concrete and in good order. It is supported on 12 tapered steel I beams, all of which are corroded (photo 9). The underside of these are fixed to the concrete wall capping and there are vertical cracks at each location (photo 10). The steel tapers are also corroded and in need of attention.

The main areas of concern relate to the vision slits on both turrets. The roof slabs are heavy and are supported on the tapered I sections which are corroding and causing some localised damage. These sections need further assessment and cleaning and protecting at best or replacing or augmenting at worst.

Investigate further condition of the tapered steel supports to the turret roof slabs; remediate or replace to ensure the integrity of the fabric.

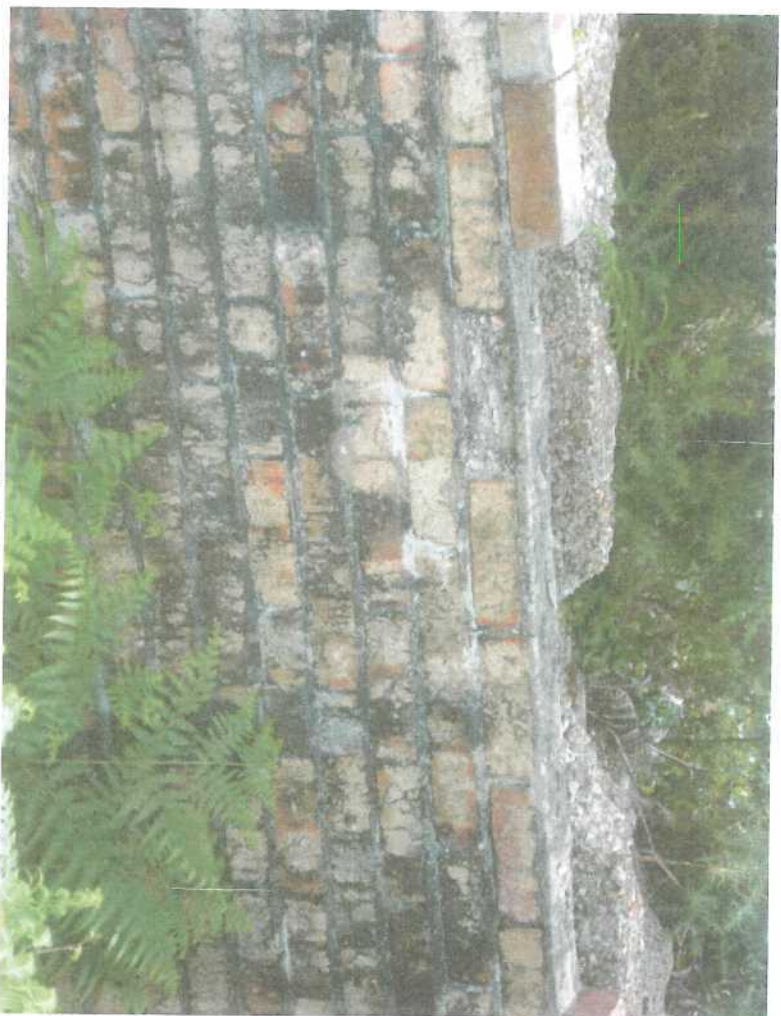
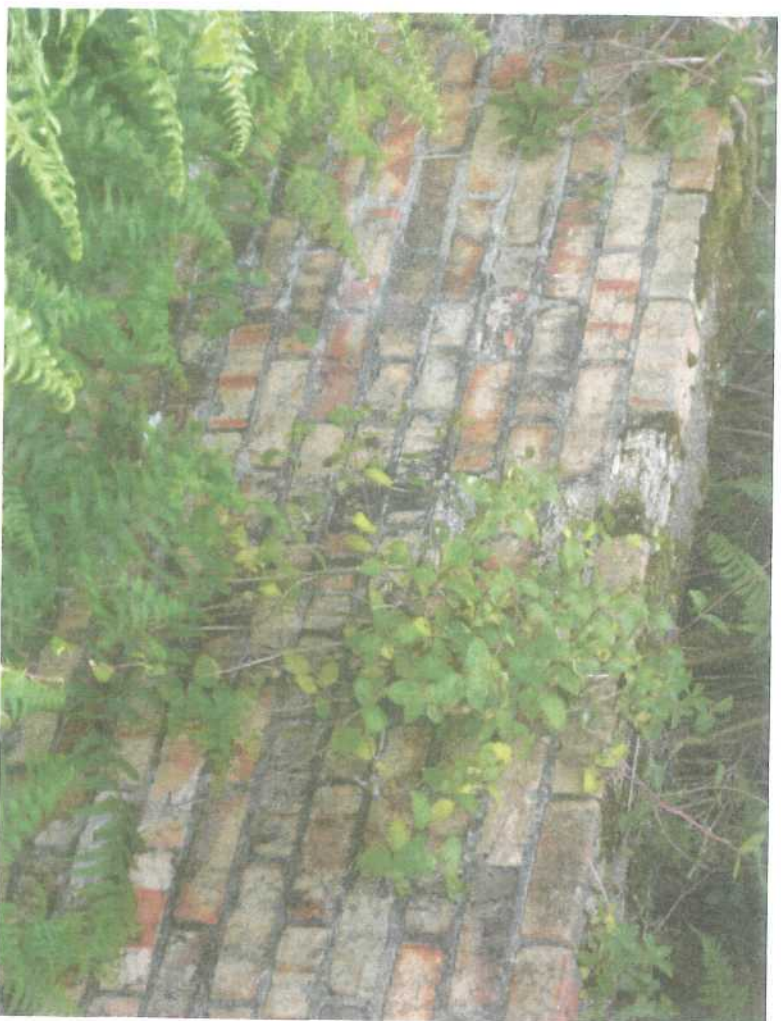
The brickwork facing appears generally sound and stable. There is some face spalling of brickwork. At the wall head, the upper courses have been lost in one or two locations exposing the concrete fill. In one location, the concrete has been damaged (photos 3 and 4).

At coping level, some bricks have been lost and these should be replaced. The main aim would be to prevent water penetrating the wall at its head which might accelerate frost damage to the brick.

Replace isolated spalled bricks as required.

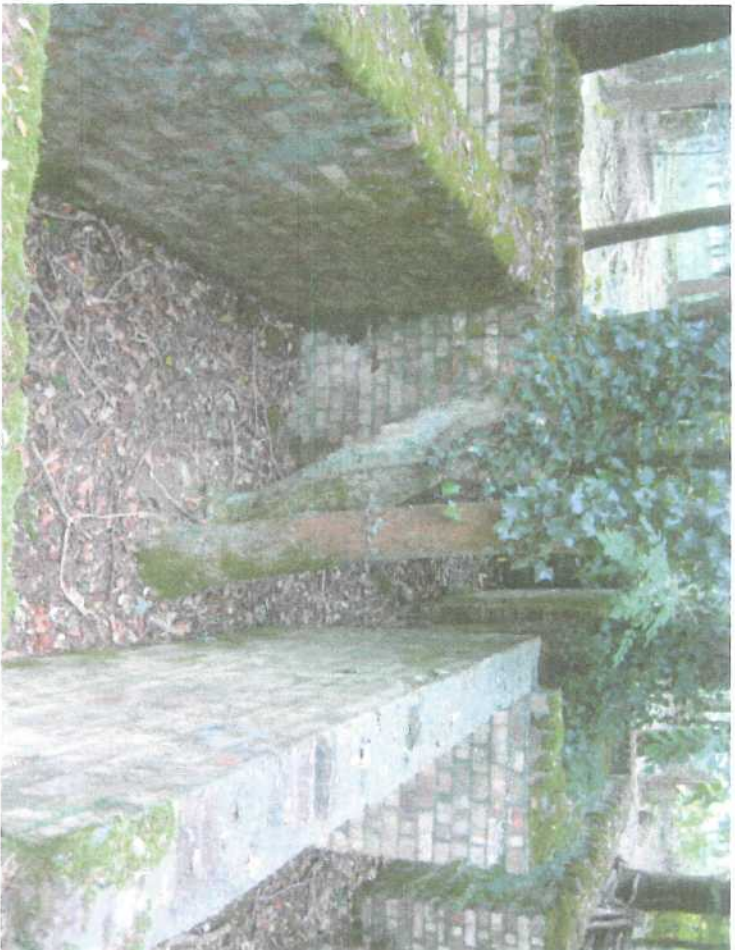
Photo 3

The brickwork walls were inspected in detail. The majority of walls are of 1½ thick brick form giving a wall width of 350mm or so; some internal division walls reduce to 1 brick thick as noted. The walls were well constructed and remain in generally good order with few defects (photo 3).

There are one or two very minor fractures in brick wall panels but none are significant.

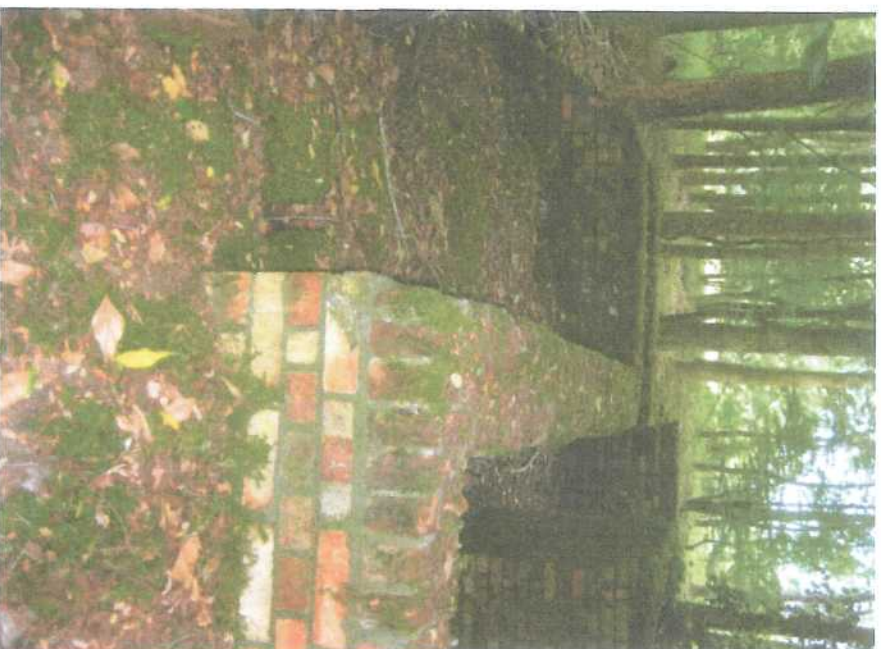
Photo 4

The wall copings are damaged in some locations with a degree of spalling in evidence. There is also moss growth on many surfaces, particularly the coping due to the woodland setting (photo 4).

Undertake brickwork repairs particularly to copings and remove moss.

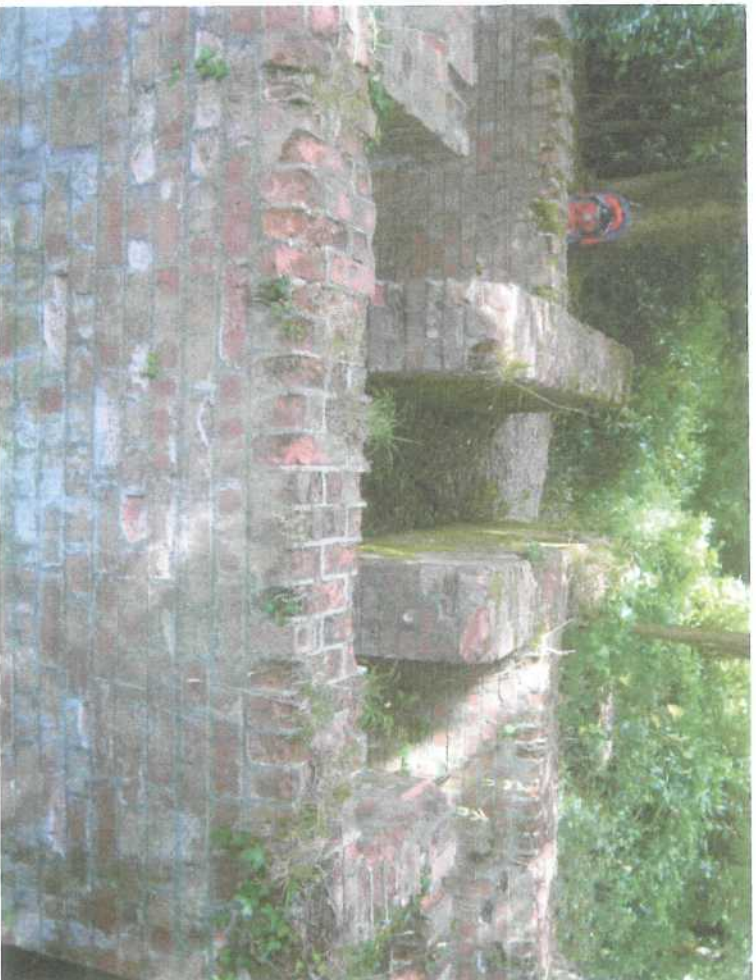
Photo 2

The brickwork walls were inspected in detail. The majority of walls are of 1½ thick brick form giving a wall width of 350mm or so; some internal division walls reduce to 1 brick thick as noted. The walls were well constructed and remain in generally good order with few defects (see photo 2).

There are one or two very minor fractures in brick wall panels but none are significant.

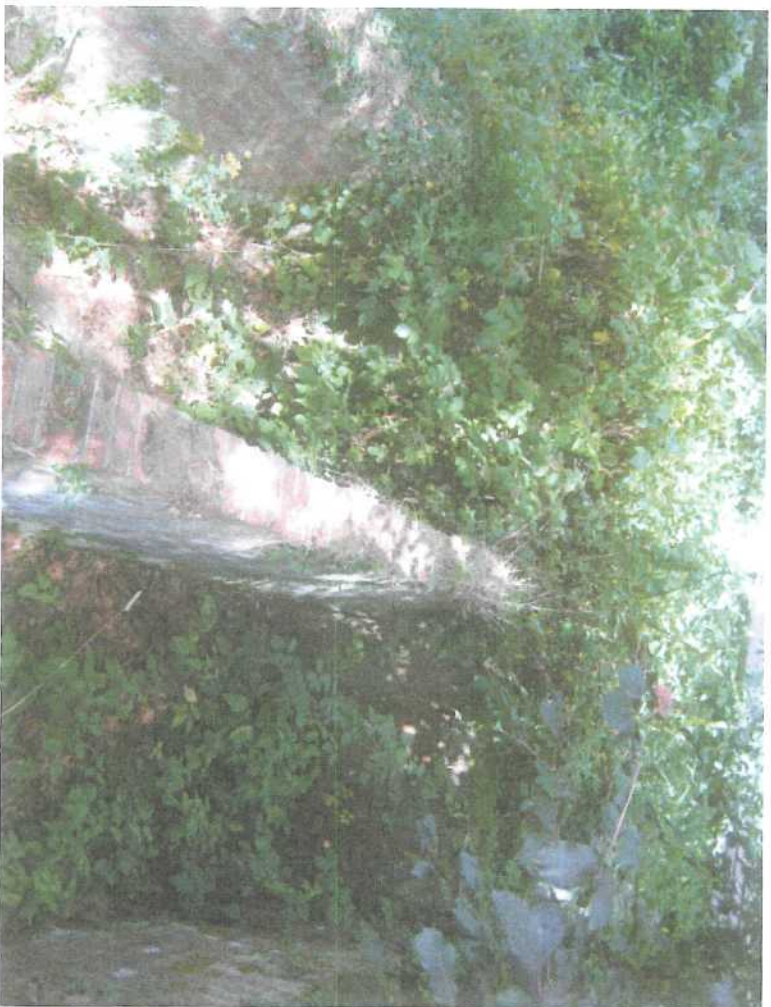
Photo 3

The wall copings are damaged in some locations with a degree of spalling in evidence. There is also moss growth on many surfaces, particularly the coping due to the woodland setting and the northern side is overgrown with vegetation (photo 3).

Remove all trees within the footprint and close by as well as vegetation on the north side. Clear out the internal footprint.

Undertake brickwork repairs, particularly to copings.

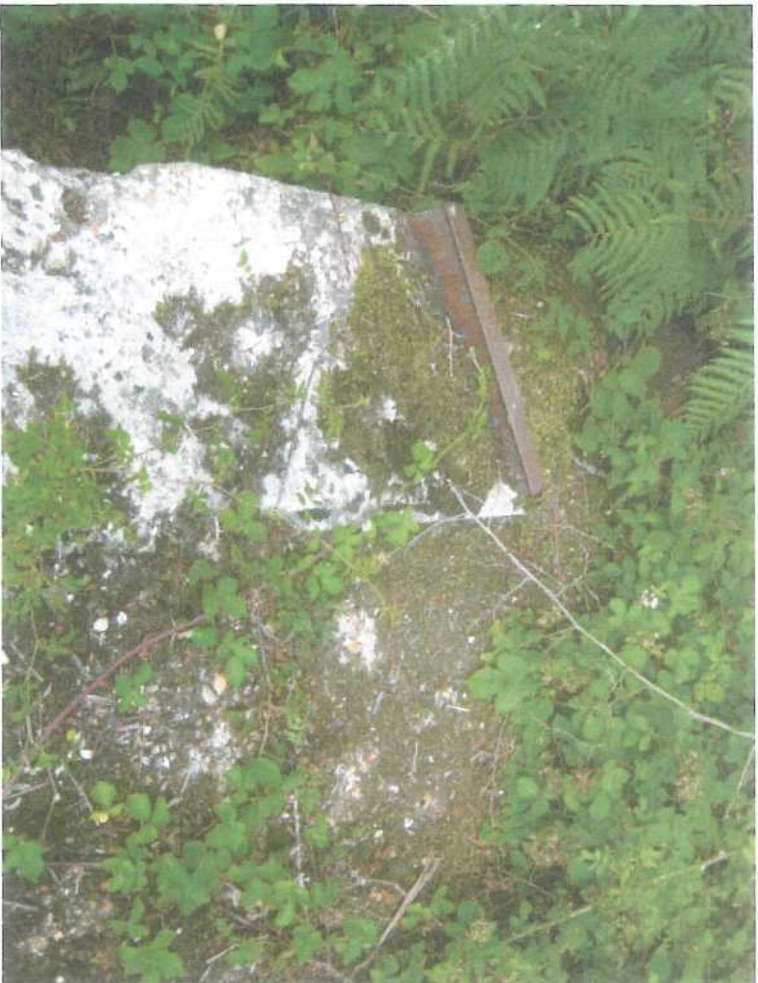
Photo 2

There is a steel I section fixed to the slab top – purpose unknown (photo 2). This appears to remain from the cupola and main entrance structures which have been removed and partially infilled. It was also noted that there are some remains of ironwork on the external face of the chamber – again their purpose is unknown.

The surviving ironwork should be examined and treated to prevent further corrosion.

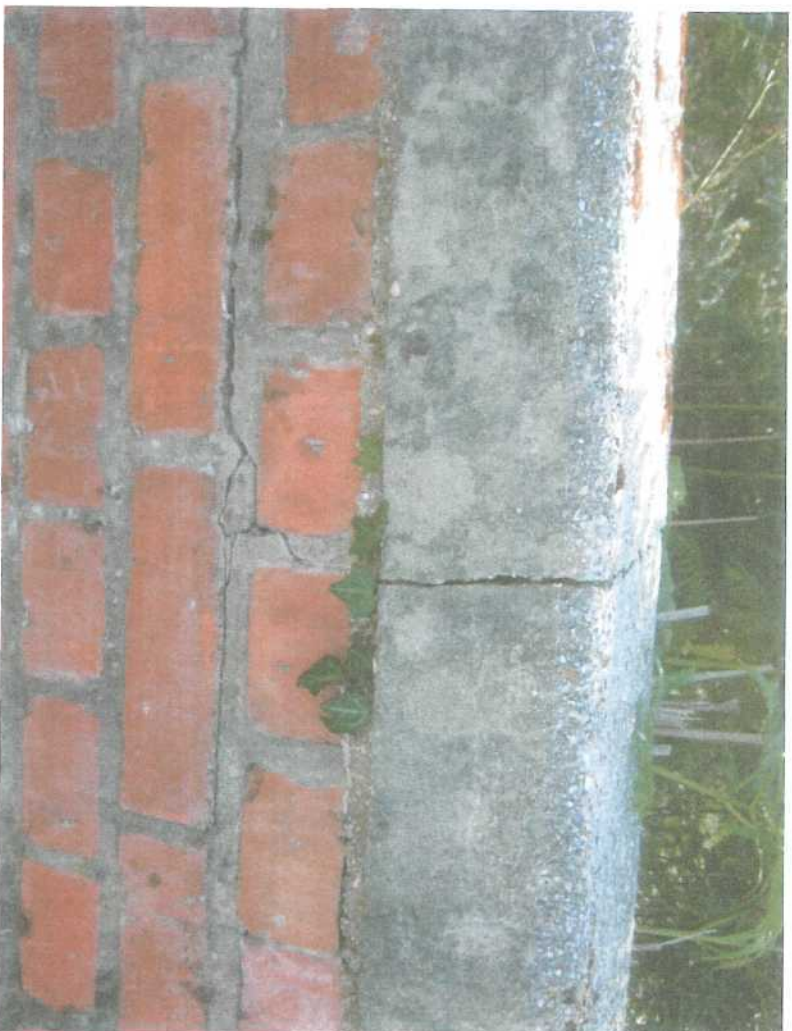
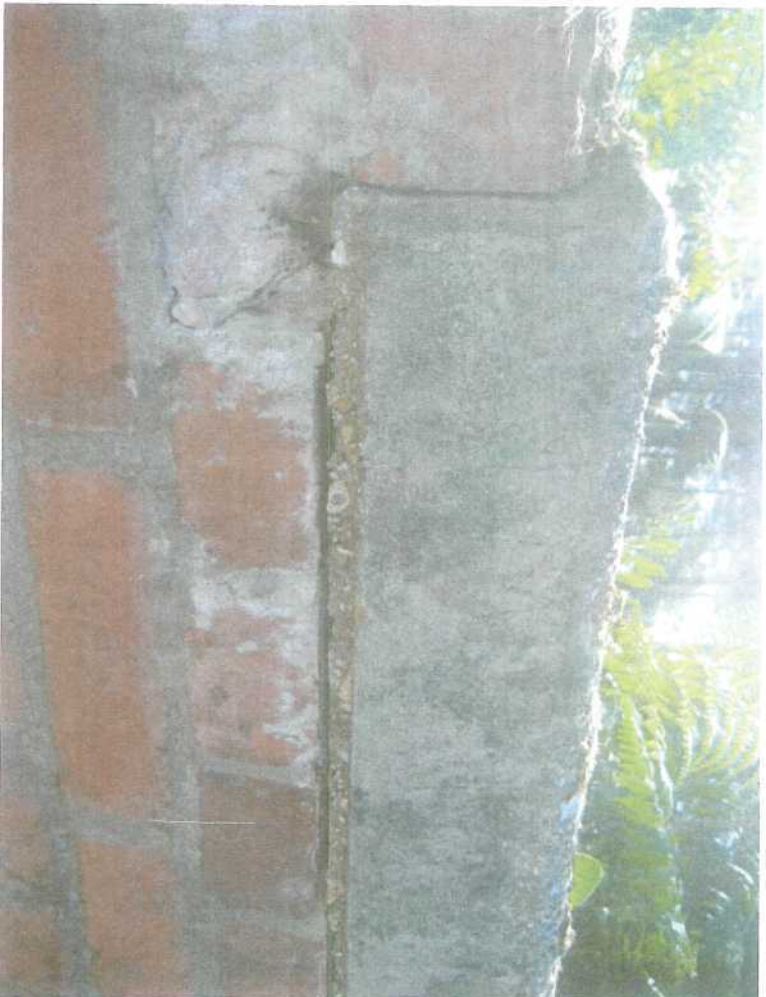
In one or two places, there are minor fractures evident in the brickwork which is not surprising given its total length without movement joints. There are several horizontal fractures evident at just under coping level and these could be due to thermal expansion; there is no evidence of iron cramping in the wall. (Photos 6 & 7)

The brickwork is in very good condition throughout with only a few repairs required and localised rebuilding where damage has occurred, as at the western end. The brick copings, where damaged or eroded, could be replaced or simply left as they stand with minor mortar repairs to ensure weathering of the wall.

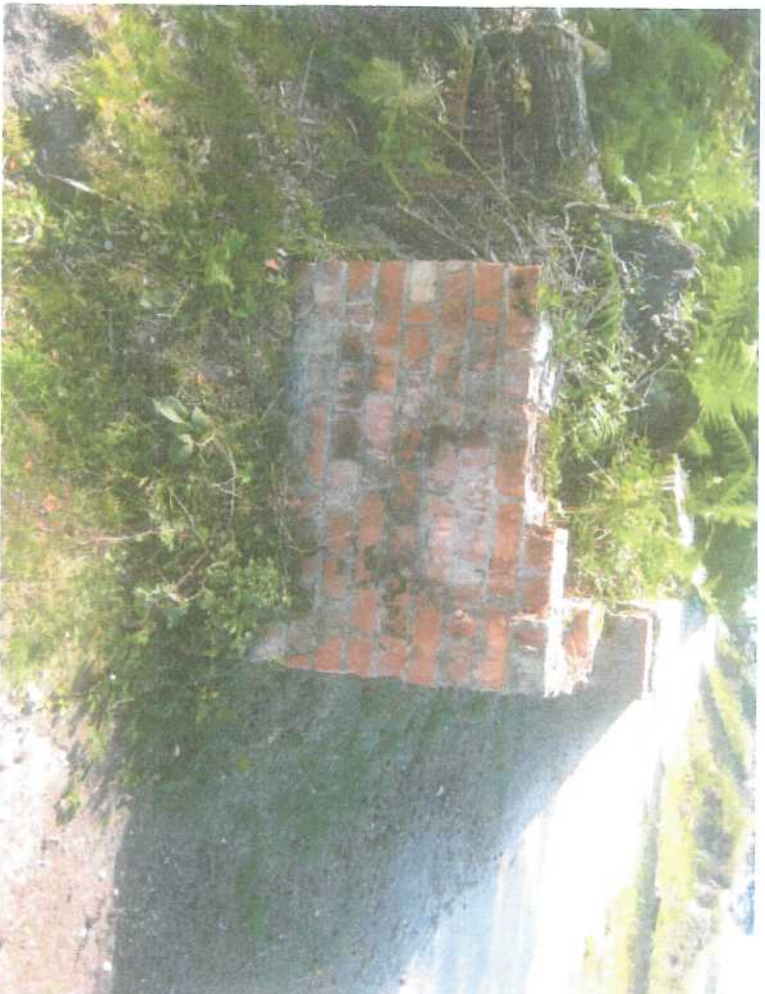
Photo 8

At the western end of the wall, the short brickwork return has been damaged with loss of the top of the wall – a section lies on the ground nearby. (Photo 8)
