# Survey of the Remains of Elements of a Mulberry Harbour

DIBDEN BAY  
SOUTHAMPTON  
MAY 2012

Anthony Burgess – Masters student in Maritime Archaeology, University of Southampton

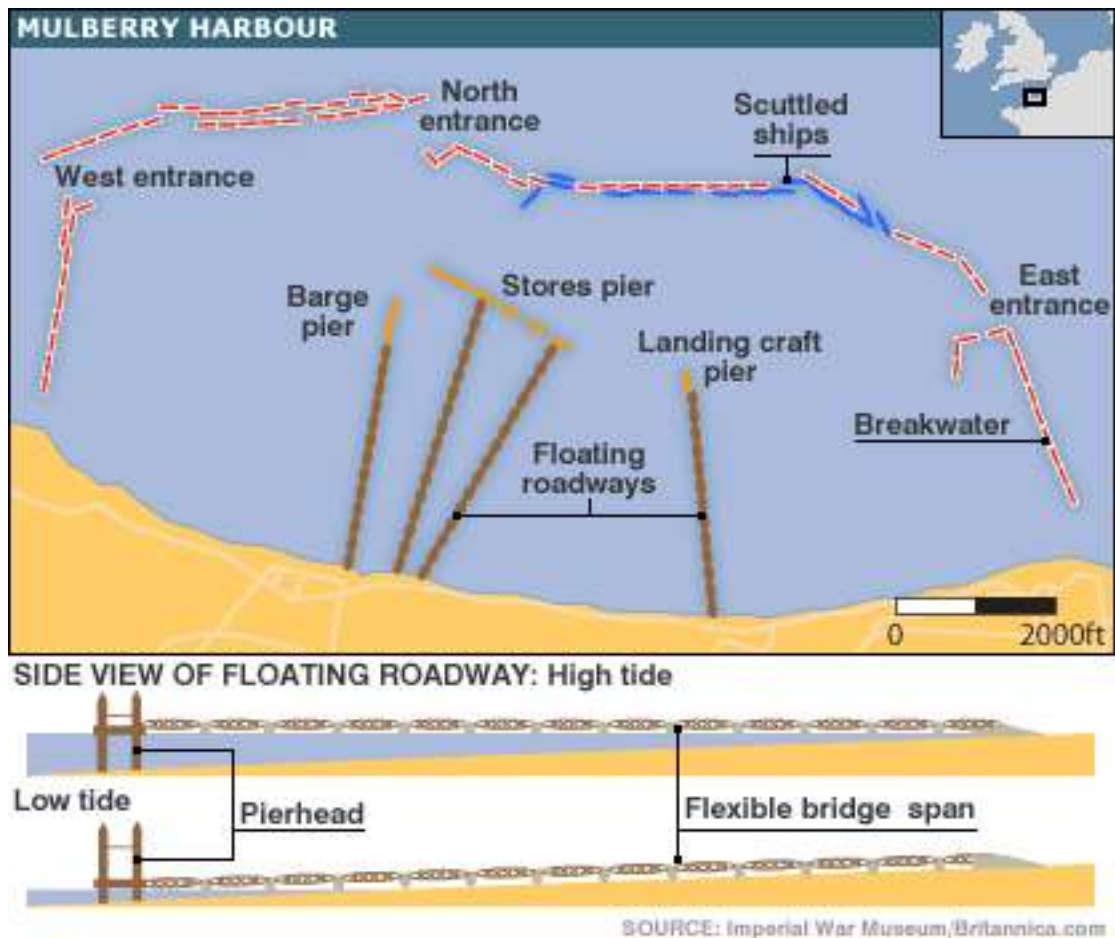
Figure 1 - Plan view of the Mulberry Harbour at Arromanches, with a side view demonstrating the rise and fall of the roadway and pierhead due to the tide, which amounted to approximately 6 metres. Concrete Beetles were used only where the water was deep enough that they would always be afloat, otherwise steel Beetles were used. Imperial War Museum website

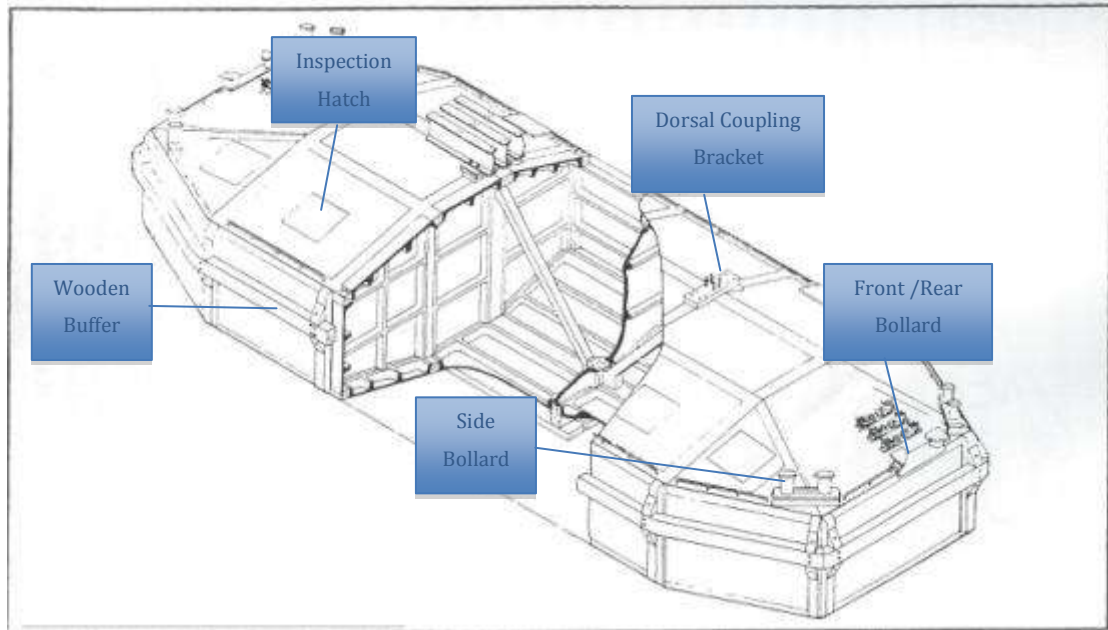
Figure 2 - Plan of Beetle with some of the key features highlighted, photographs of which can be found in the Photo Glossary. Hartcup 2006 (feature boxes and nomenclature author's own)

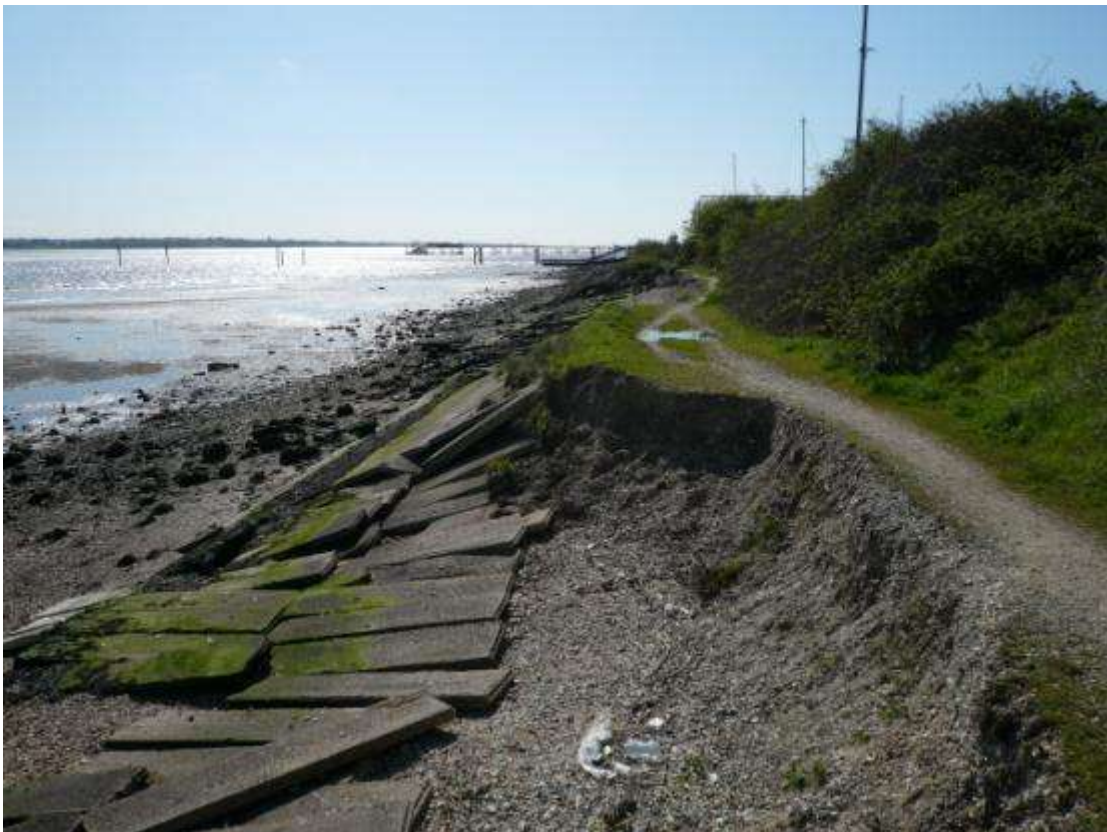
**Figure 3 - Photo looking back towards Hythe from south of the site, showing local failure of the coastal defences**

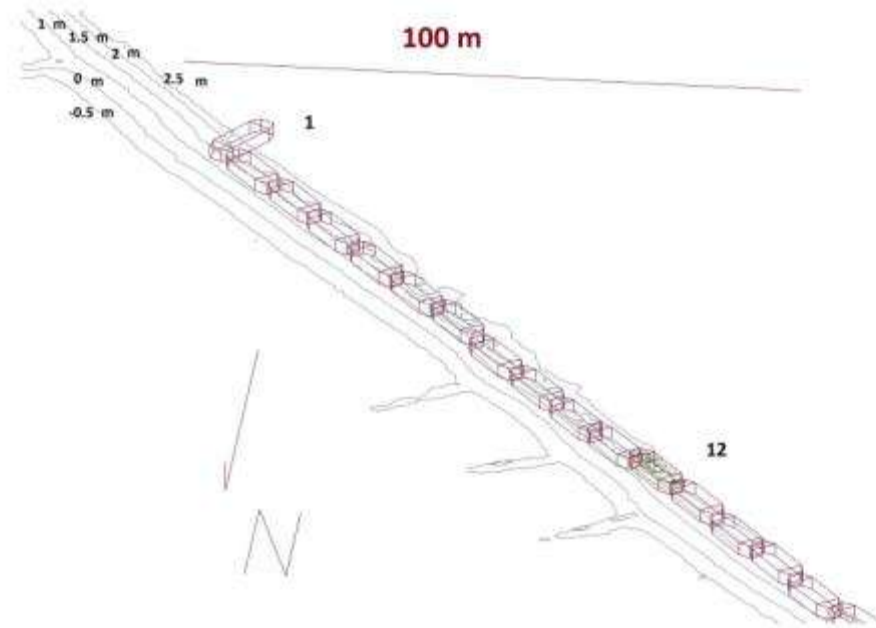
Figure 5 - Autocad depiction of Section A and the lower half of Section B, making clear the contra-orientation of Beetle no.1. The contour lines depict the beach slope at 50cm intervals, commencing at -0.5m below sea level (OD Newlyn)

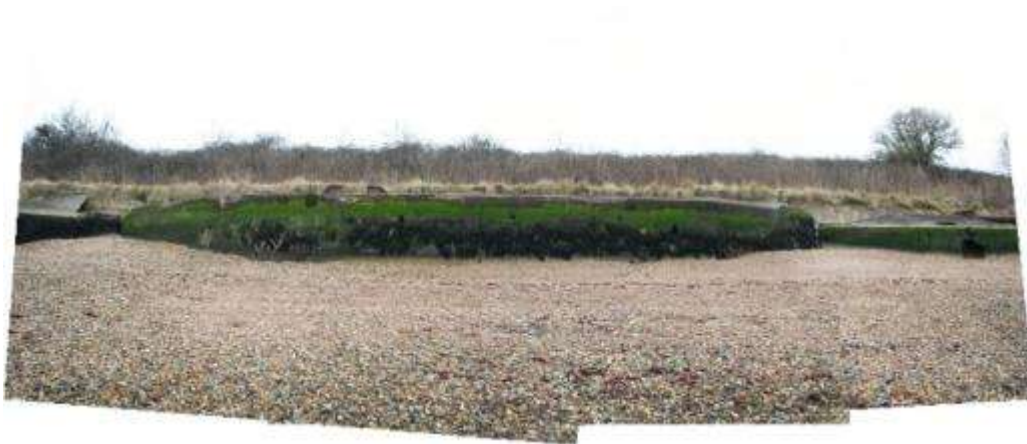
**Figure 6 - Beetle 12. Northwest is to the right**

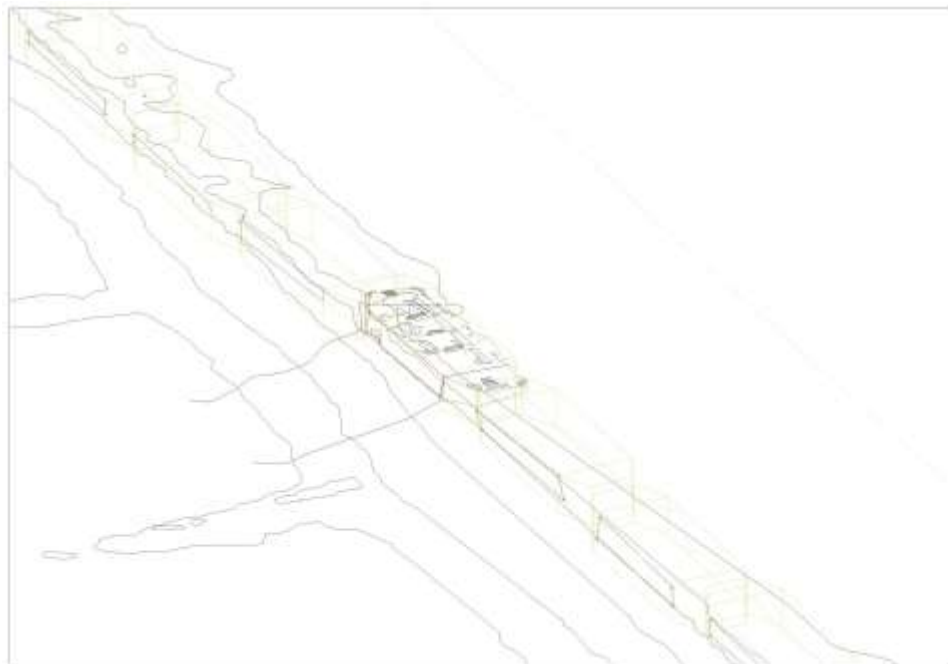
**Figure 7 - Autocad depiction of Beetle no. 12 RTK points, combined with CCO LiDAR data. The degree of entrenchment in the bank is clear. The contour lines depict the beach slope at 50cm intervals, commencing at -0.5m below sea level (OD Newlyn)**

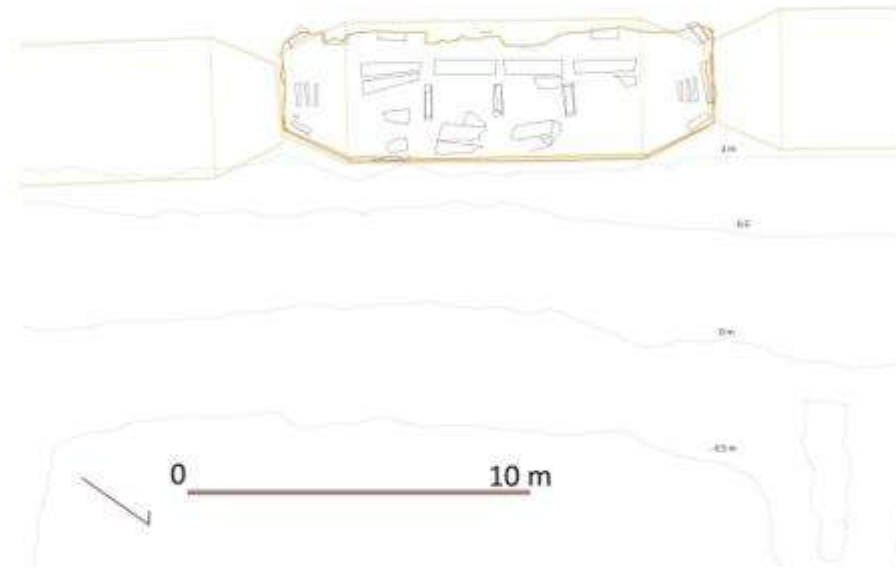
Figure 8 - Autocad depiction of Beetle 12 based upon RTK data, combined with CCO LiDAR data, displaying the encroachment of the bank. The contour lines depict the beach slope at 50cm intervals, commencing at -0.5m below sea level (OD Newlyn)

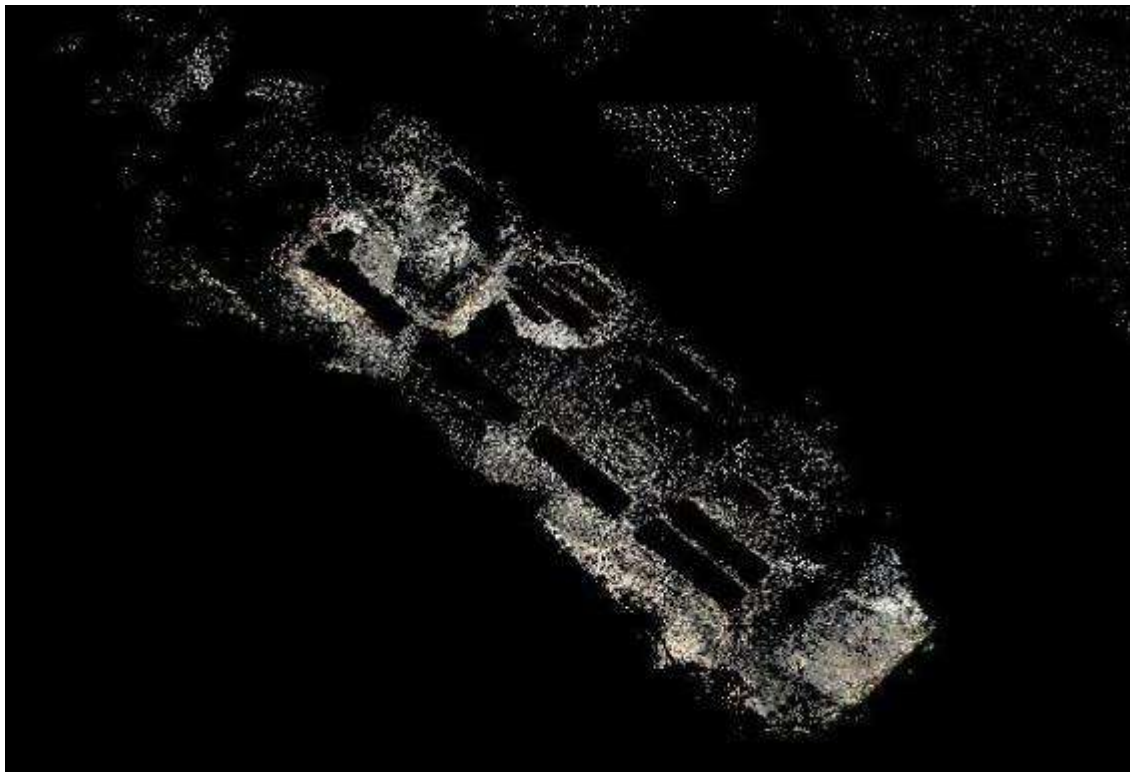
Figure 9 - Point cloud of Beetle no.12, generated by Microsoft Photosynth. Orientation of Beetle SE-NW (top left to bottom right)

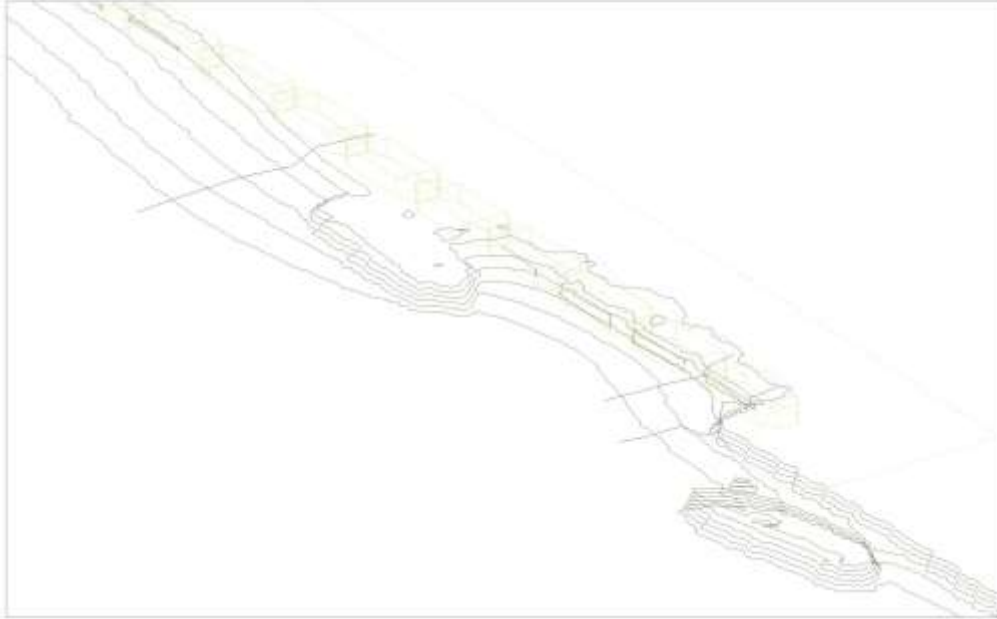
The submergence and exposure of Sections C and D respectively has been caused by the placement of a concrete lighter further into the inter-tidal area adjacent to Beetles nos 35 & 36 (Figure 10, Figure 13 & Figure 50) and the outer edge of the fence of Stage 1 of the reclaim. It is not known when this vessel was placed on site, only that it appeared between 1967 and 1999 (RAF photos and Google Historic Imagery).

Figure 10 - Autocad depiction of Sections C & D RTK points combined with CCO LiDAR data, depicting the distortion of the beach profile. The contour lines depict the beach slope at 50cm intervals, commencing at -0.5m below sea level (OD Newlyn).

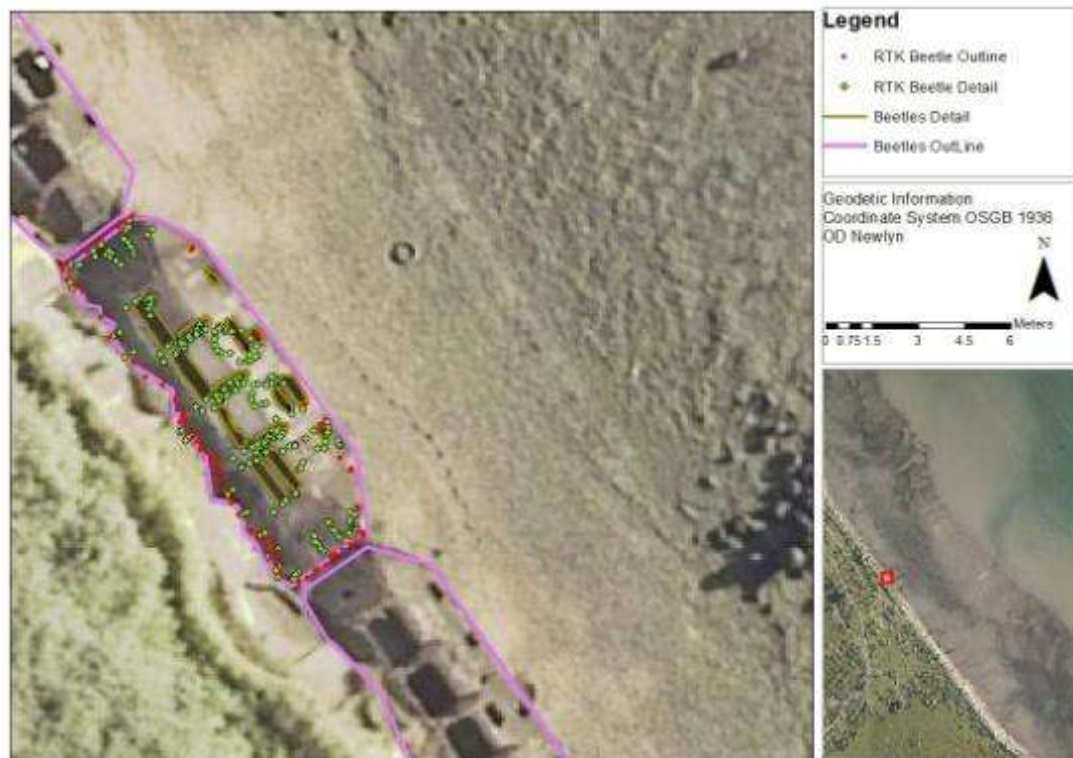
Beetle 12 was profiled in detail (Figure 14), both with RTK Smartnet and with photos. Beetle 15 was also extensively photographed; these Beetles were selected due to their good condition and their prominent profile above the beach.

Figure 14 - RTK Smartnet points taken of Beetle no.12. Aerial photo courtesy of CCO.

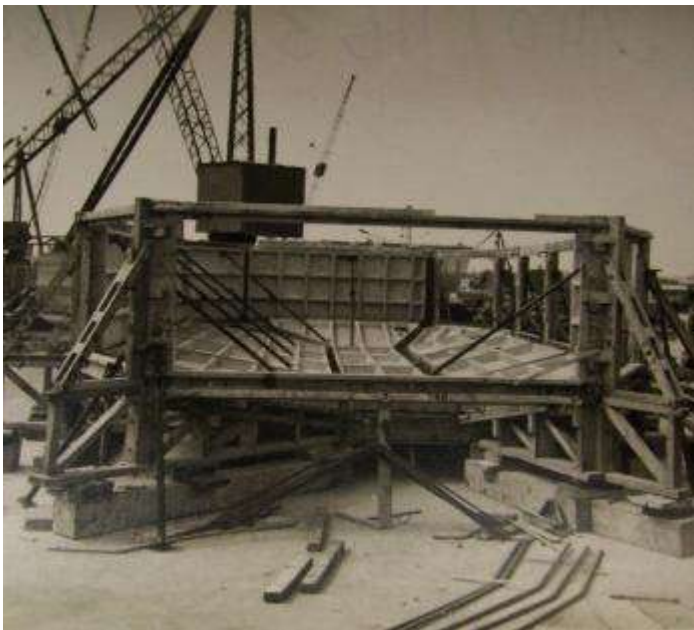
Figure 42 - Beetle mid-assembly showing the internal framing. National Archives ref. WO 240/1163

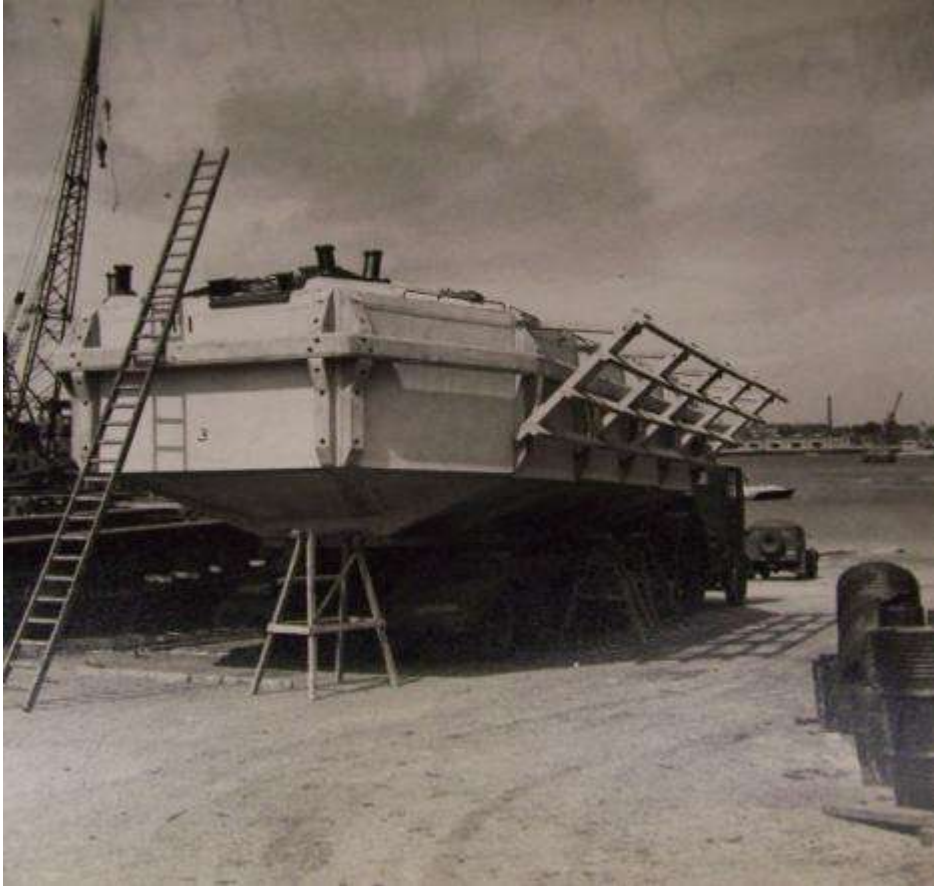
Figure 45 - A completed Beetle awaits launch. The function of the grill on the starboard side has not been established. National Archives ref. WO 240/1148

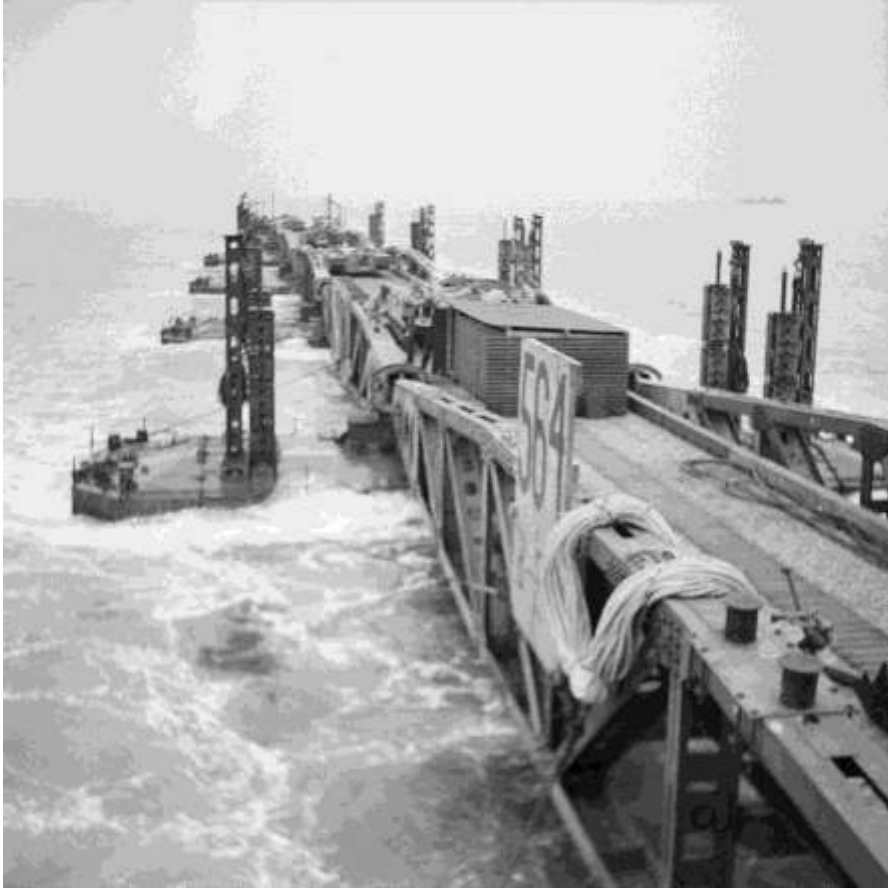
**Figure 47 - Whale unit being towed to France. Note the hydraulic jacks on the Beetles indicating that these are made of steel not concrete. Picture ref B-005689 IWM**

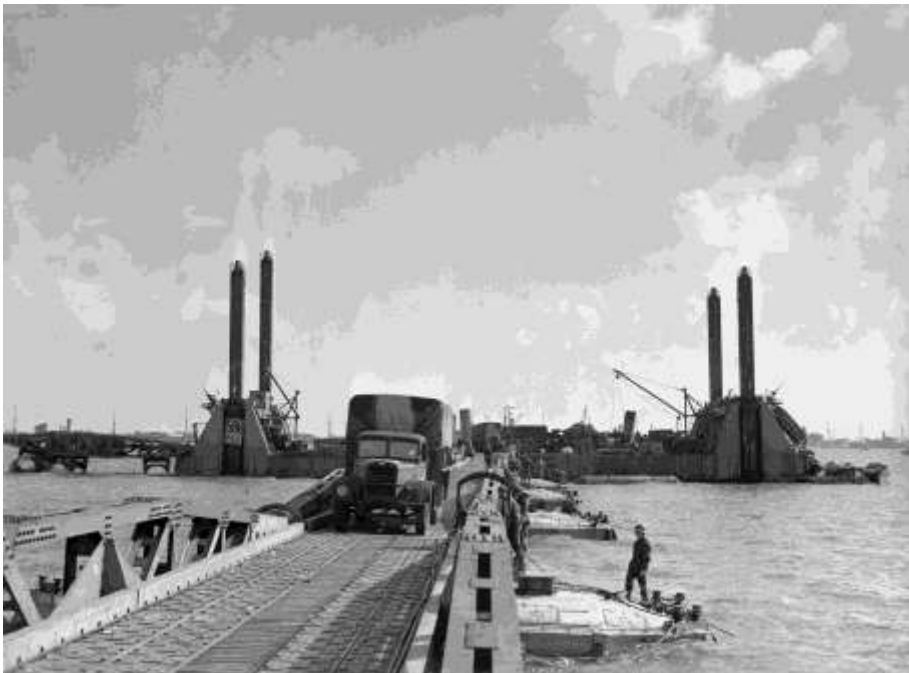
**Figure 48 - Whale unit in situ in France, showing the floating roadways, the piers with hydraulic jacks and in the background, the blockships. Picture ref A-024362 IWM.**

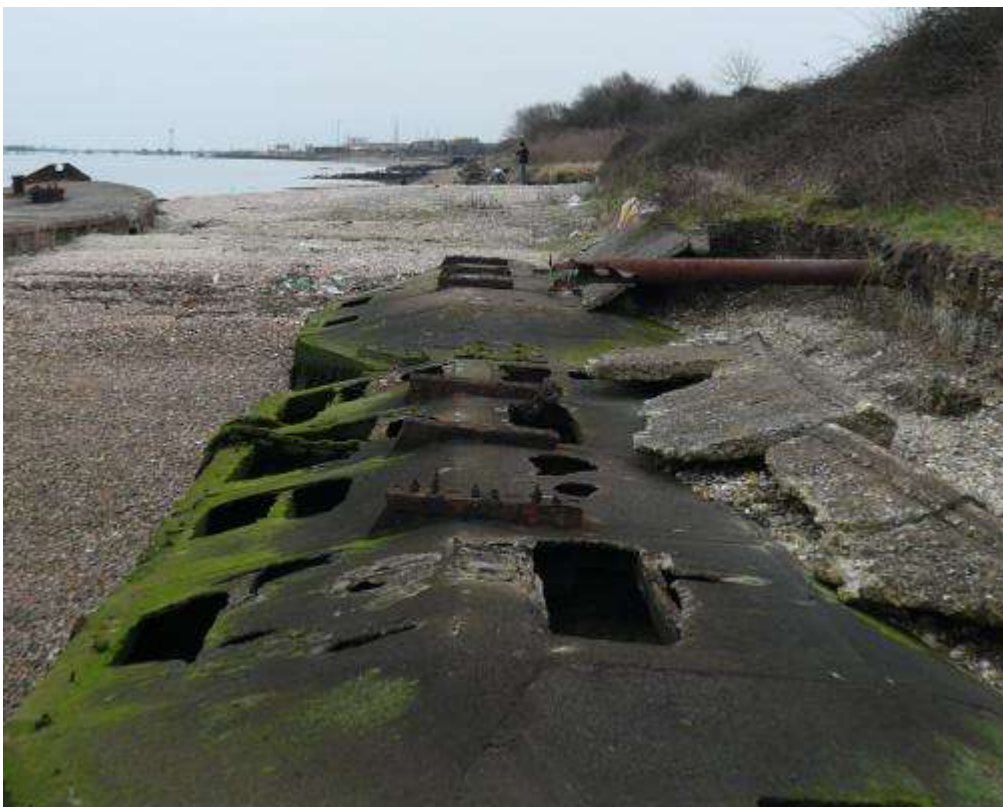
Figure 50 - Looking southeast from Section D, highlighting the shingle ridge caused by the concrete lighter to the left of picture

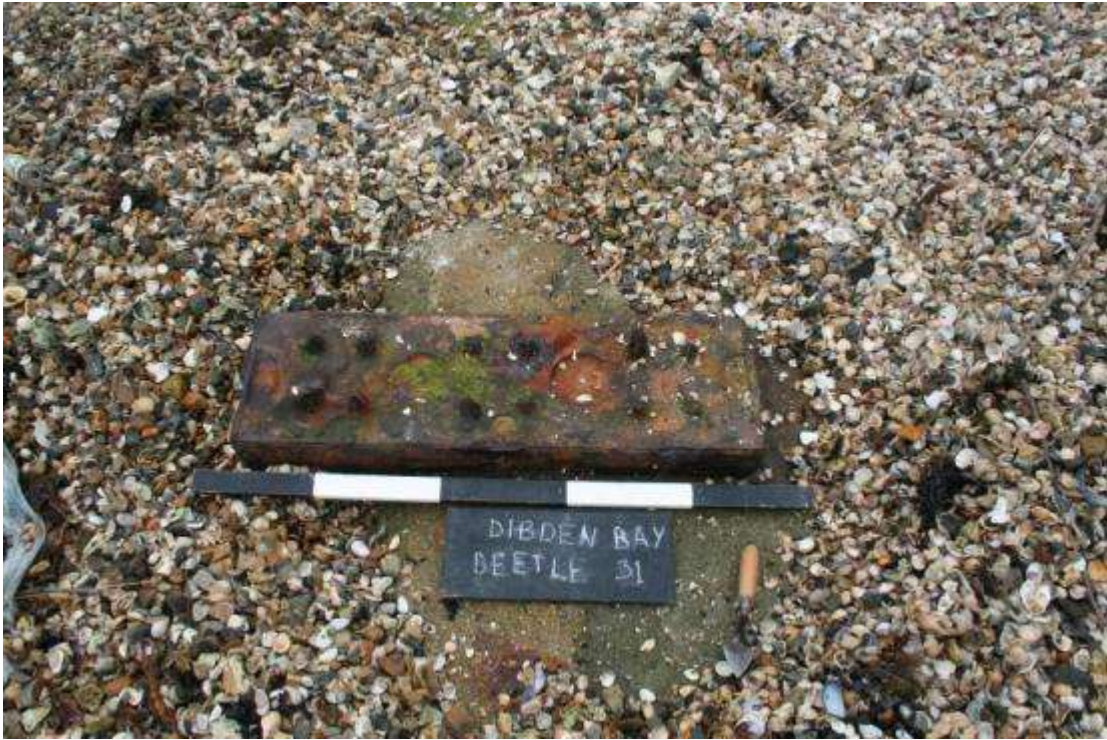
Figure 51 - Exposed dorsal coupling bracket of Beetle no.32 (not 31 as stated on slate). Trowel points to north

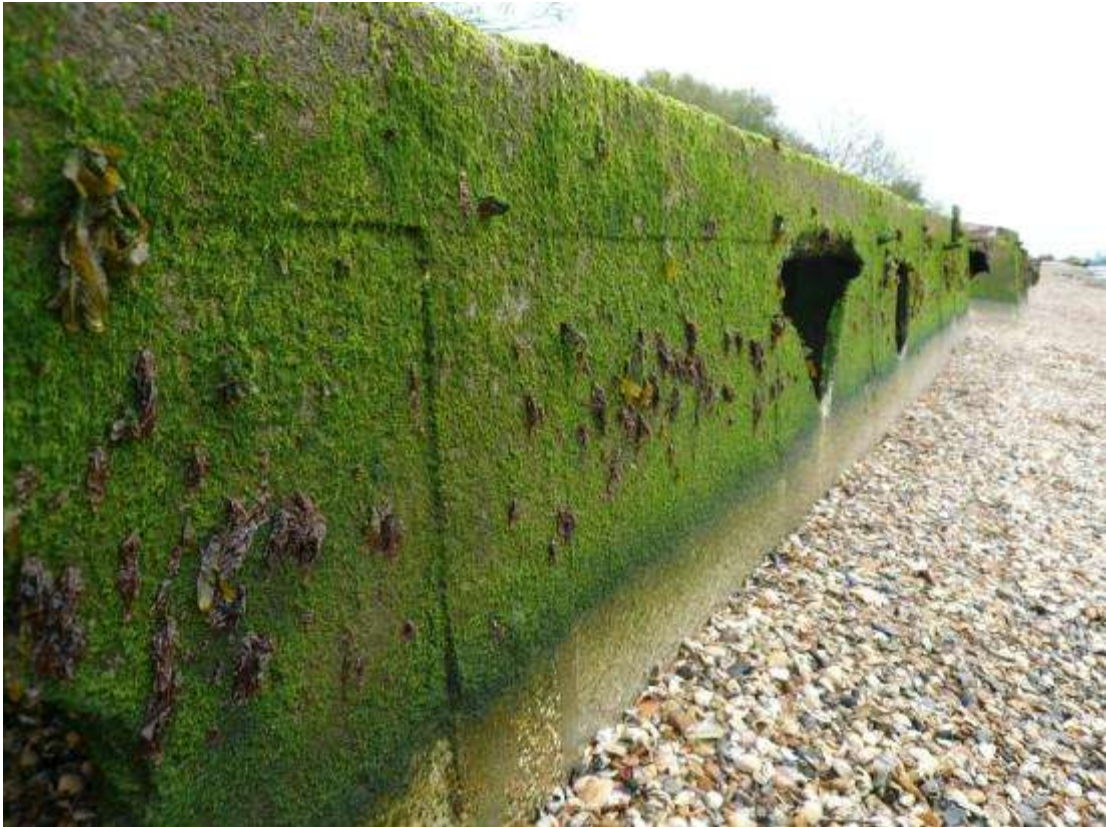
Figure 53 - Looking northwest up the line of Beetles - note the undamaged moss-free area at the base of the Beetles indicating beach motility and how the breaches in the side correspond to this level

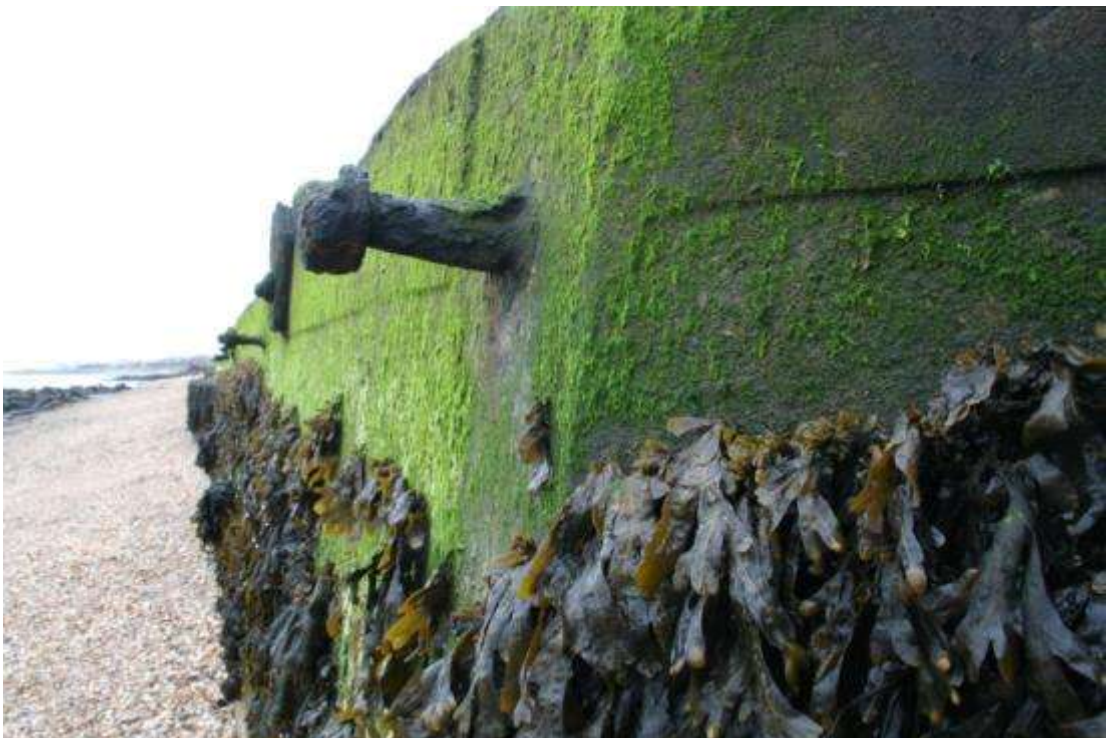
Figure 54 - Looking southeast down the line, these features were used to secure the wooden buffers and also appear in the construction photos in Section 8.2.2

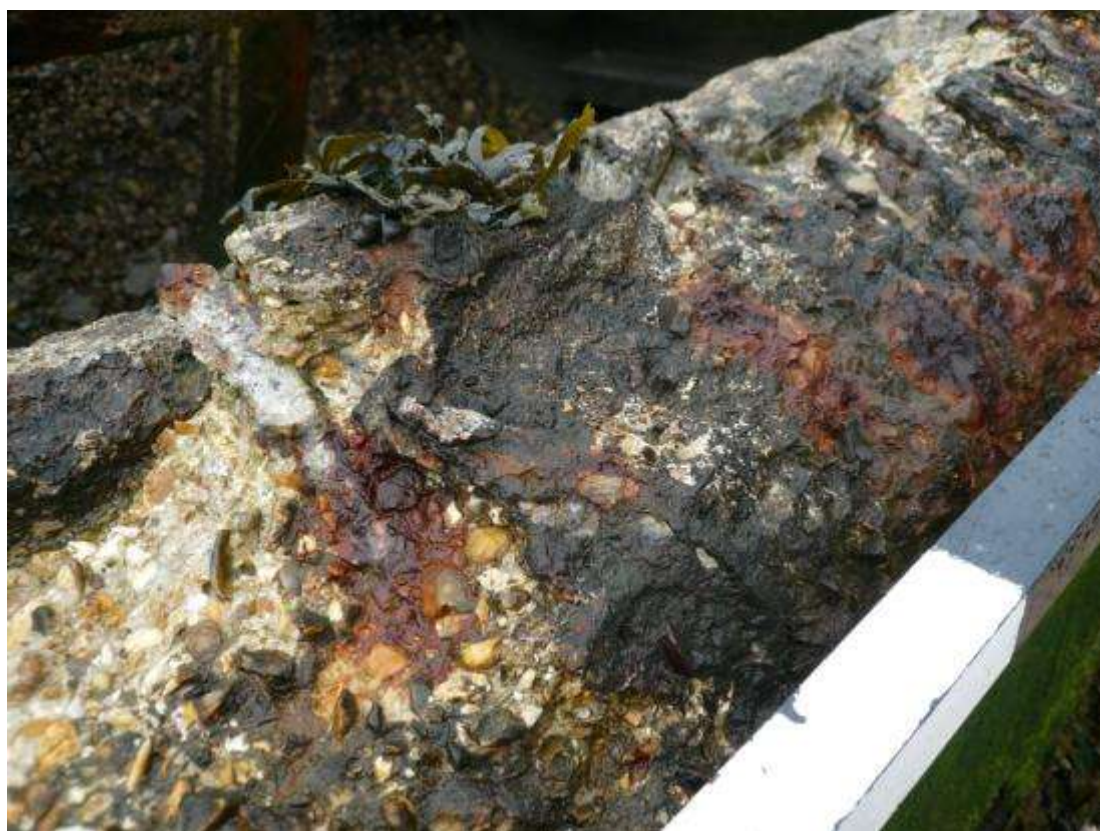
Levels of deterioration vary widely on the site (see Section 8.5), although the overall site condition can be summarised as declining. The three principal components of concrete, metal and wood have predictably survived at differing rates. The presence of wood is restricted to small quantities attached to metal protuberances (Figure 55), whilst all that remains of some of the metal are corrosion stains (Figure 56). In some

Figure 56 - Corrosion stains

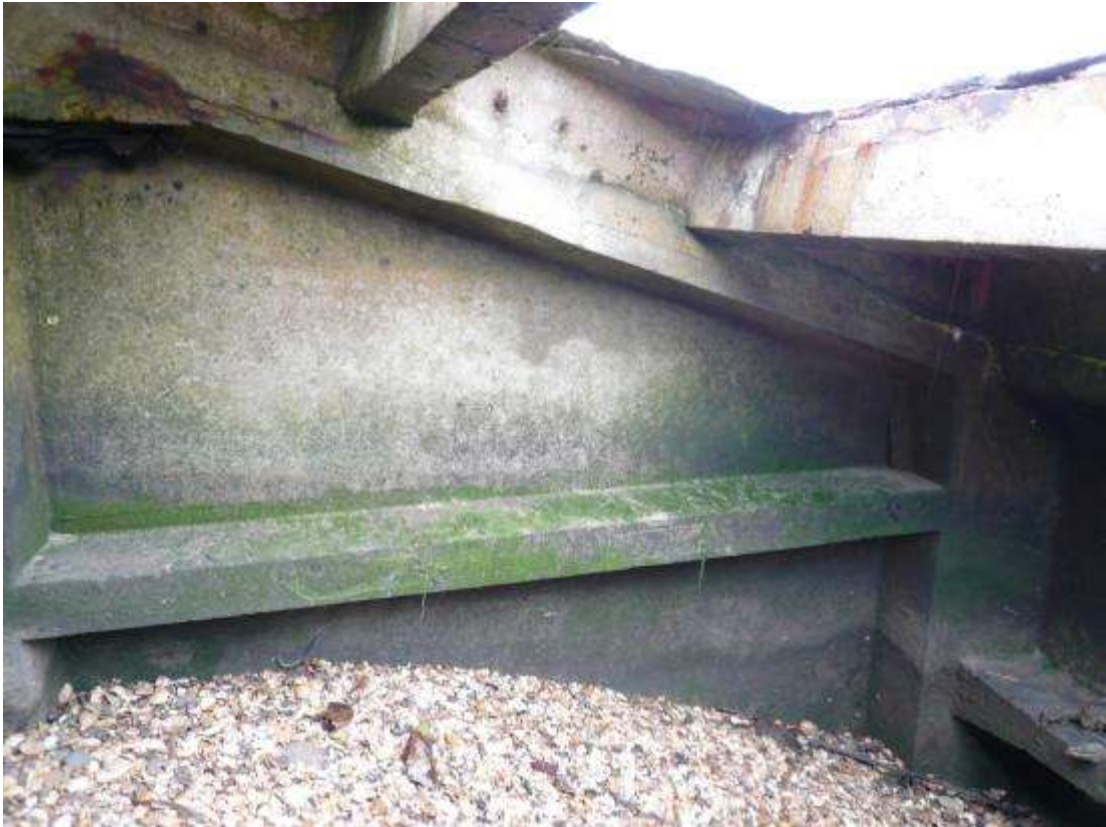
**Figure 57 - Interior of Beetle showing the durability of the internal bulwarks used to create the watertight compartments**

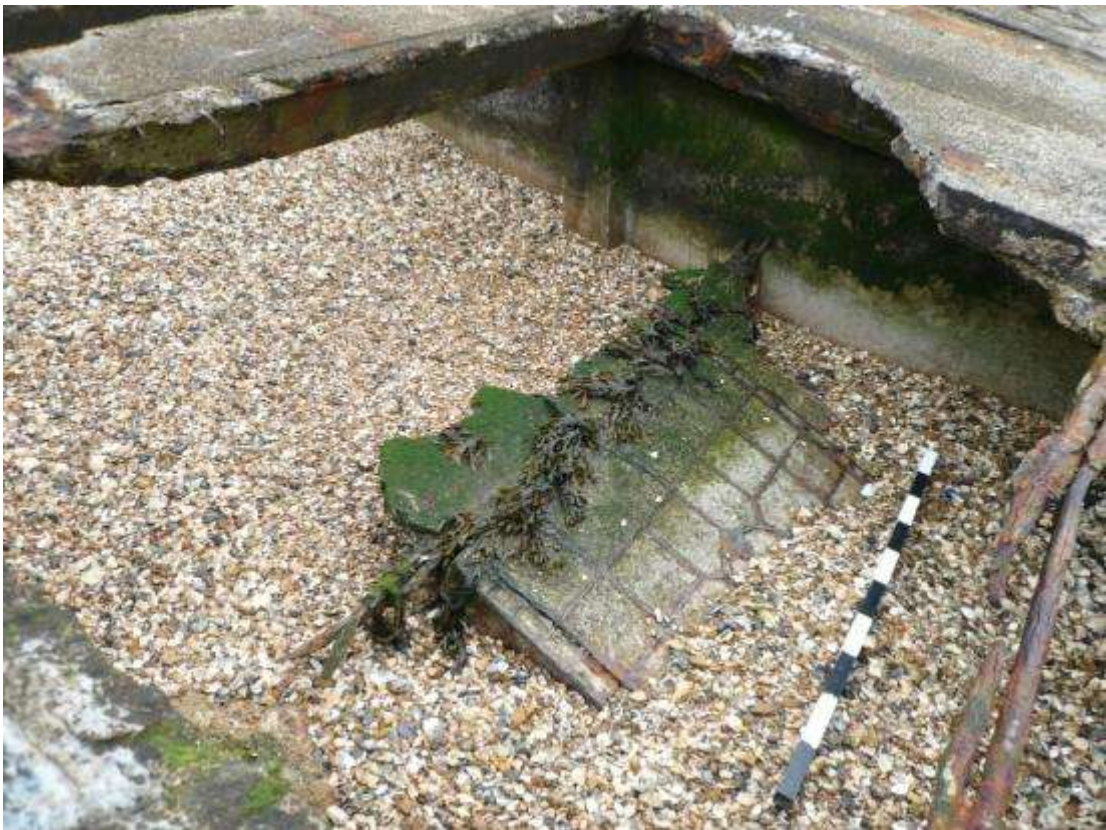
sections, the metal has been weakened to the point where it is unable to support the weight of the concrete it previously reinforced (Figure 58). The concrete has generally fared better, although this has perhaps more to do with the quantity – if the concrete had been more resistant, then the reinforced metal within would have avoided exposure and deterioration. Again, conditions vary widely from Beetle to Beetle, with some appearing to be in almost pristine condition (Figure 59 - Beetle no.4) whilst others have suffered a great deal of deterioration (Figure 60 - Beetle no.3).

**Figure 58 - Collapsed section of a Beetle, clearly showing the eroded metal reinforcements**

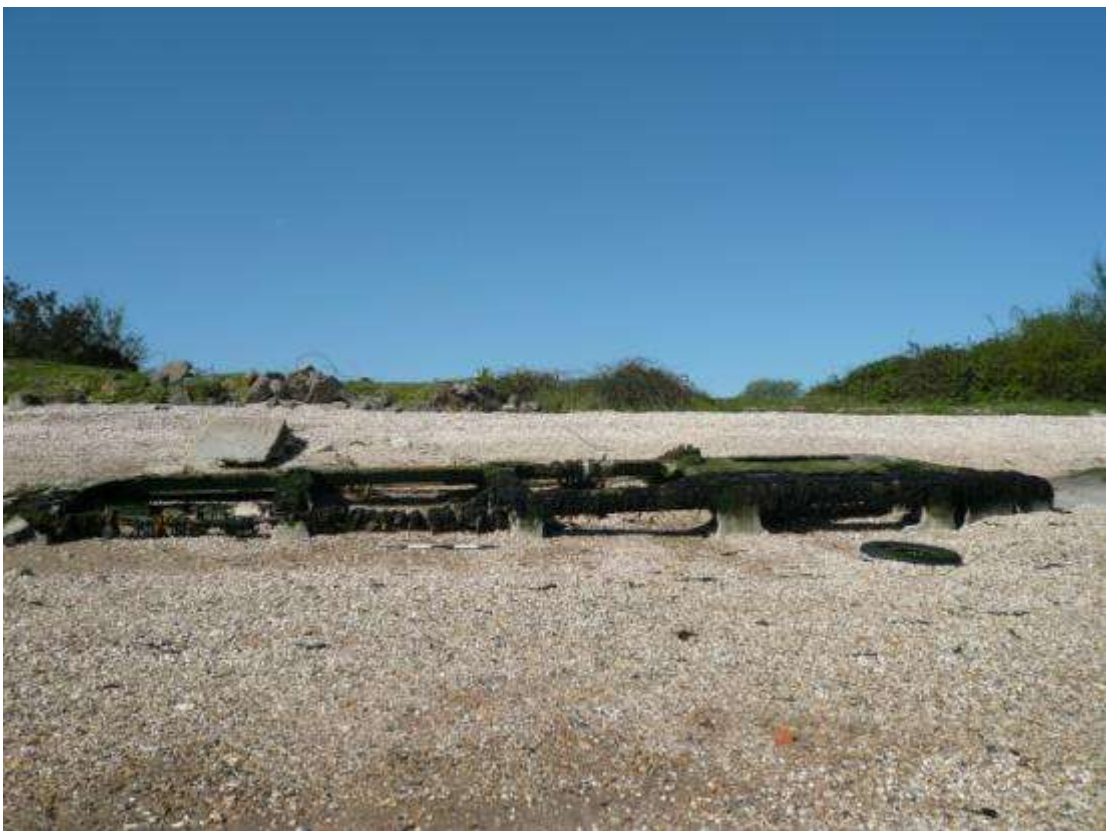
Figure 60 - Beetle no.3. Northwest is to the right.

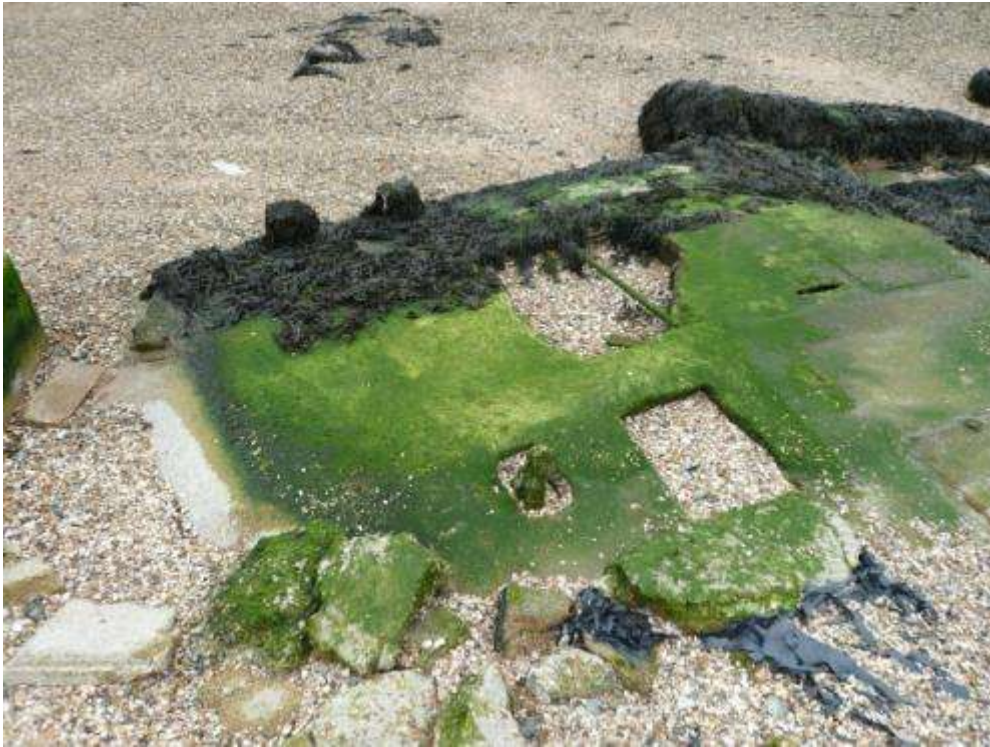
Figure 61 - Beetle no.1 with the wooden post protruding in the centre bottom of picture. Northwest is to the left.

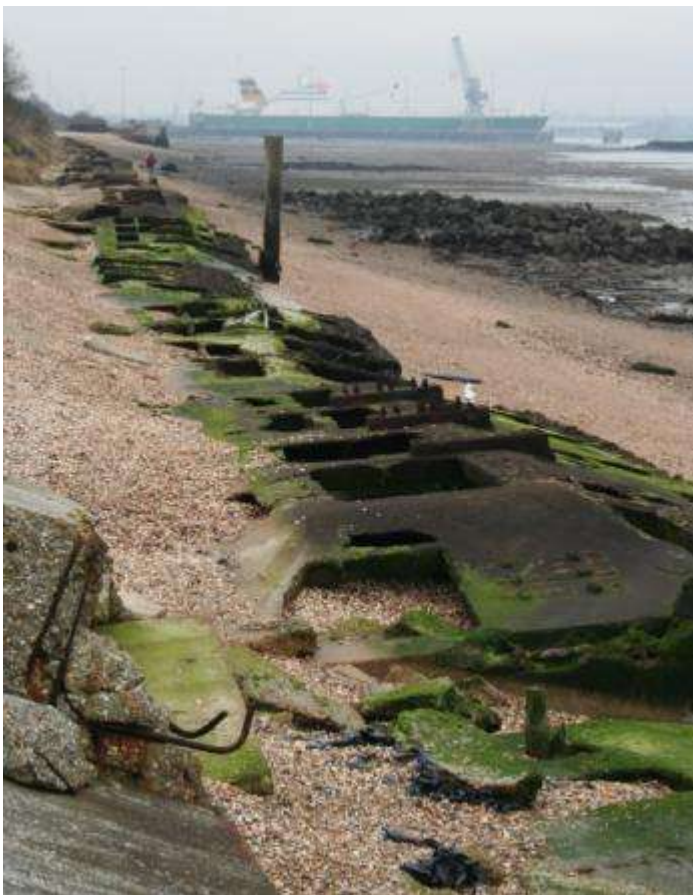
Figure 62 - Site photo looking northwest showing the predominance of dorsal algal growth at the southern end of the site, indicating that the tidal effect here is not uniform. The wooden post in Beetle no.1 and concrete remnants (possibly of a pier) can be seen in the foreground.
