## Were there submarines in the New Forest during the Second World War?

An investigation into the purpose of the large concrete structure built on the Ashley Walk Bombing Range during 1941. Was it in fact a replica of German submarine pens or was it something else?

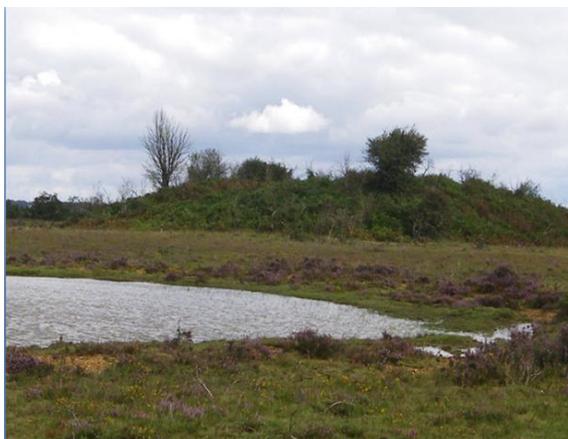
**The Submarine Pens:** This structure of reinforced concrete was built to the south of Pitts Wood. It comprised a concrete slab 79 feet by 70 feet by 6 feet thick supported by 5

Fig 1 Sub Pens 2012

unequally spaced walls 6 feet in height and being open at two ends. The whole structure was built on a reinforced concrete slab. After the closure of the Range in 1946 the structure was covered in earth rather than demolished. In fact this covered structure has caused confusion over the years as it is shown on the current OS map as a tumulus. There is, in fact, a tumulus about 150 metres west of the sub pens which survived the war but shows clearly on pre-war maps in its correct position. It was surveyed by Heywood

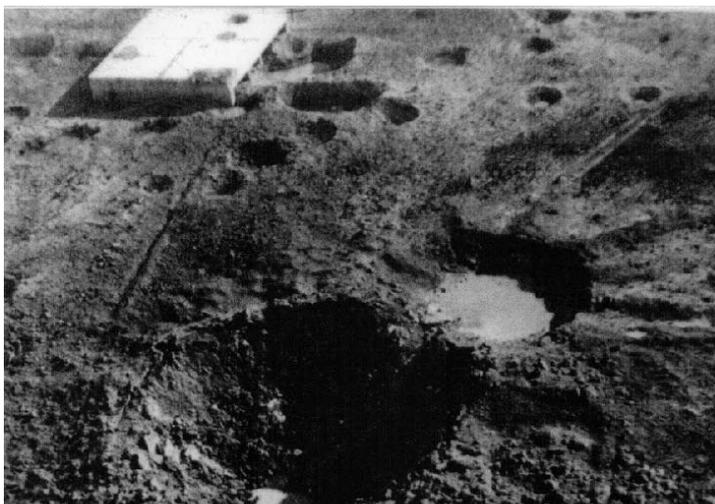
Until recently there were only two known photographs of the sub pens and one is shown in **Fig 3**. The structure is at the top left of the photo and clearly shows damage which will be discussed later. The shape of the structure is similar to the German submarine pens so it is

Fig 3 Sub Pens top left in 1945 (crater resulting from testing the Grand Slam bomb in March 1945 middle front)

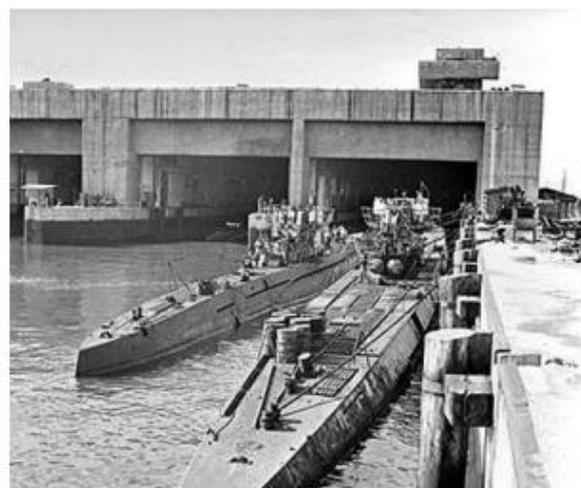
**Fig 4** shows the U Boat pens at Trondheim. The resemblance to the Ashley Walk structure is apparent but note the massive

Fig 4 Dora sub pens at Trondheim

roof construction. Some of these roofs could be 30 feet thick!

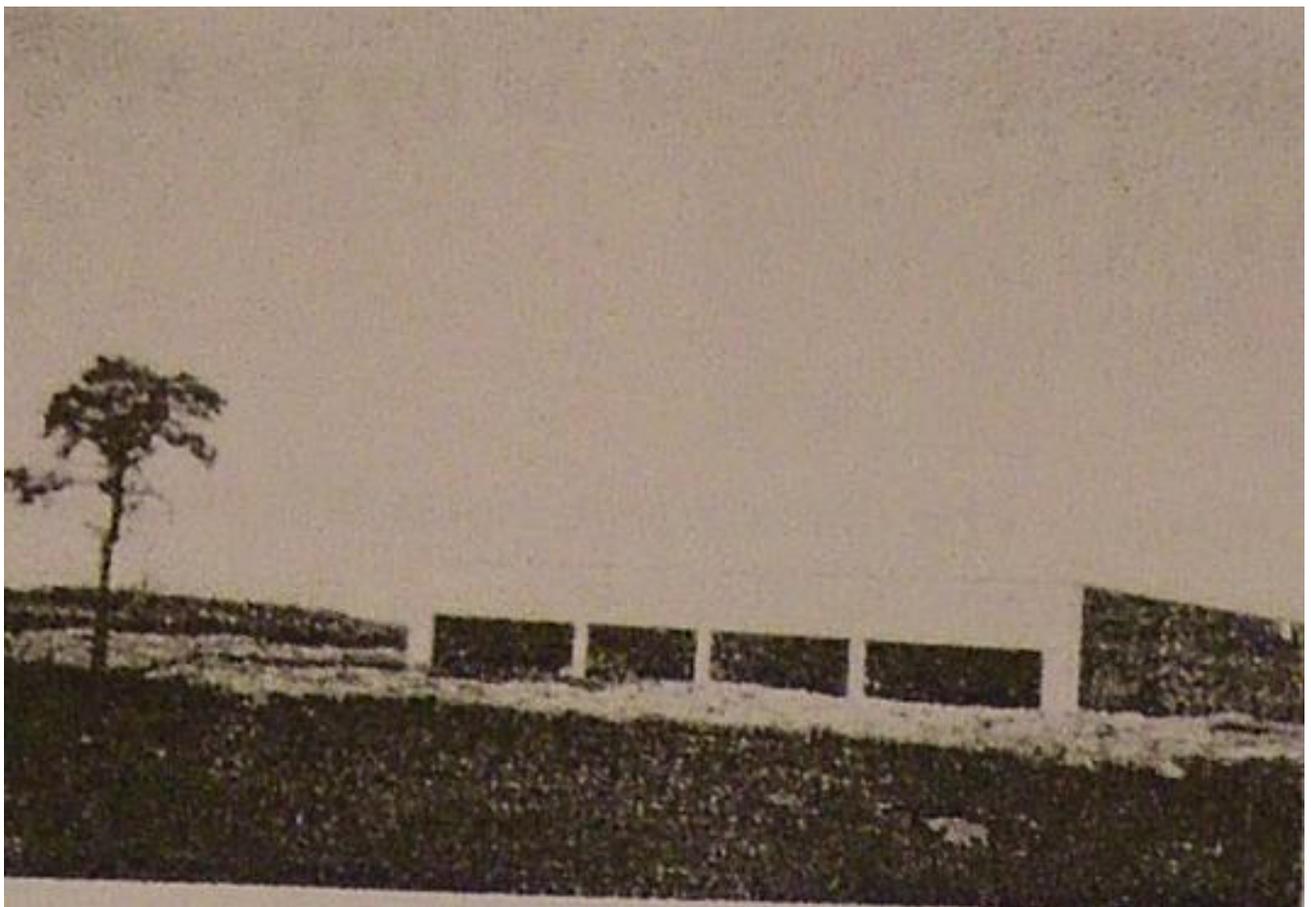
**Fig 6** shows a photograph of the target shortly after its completion and before any tests had taken place

**Fig 6** Target immediately after completion

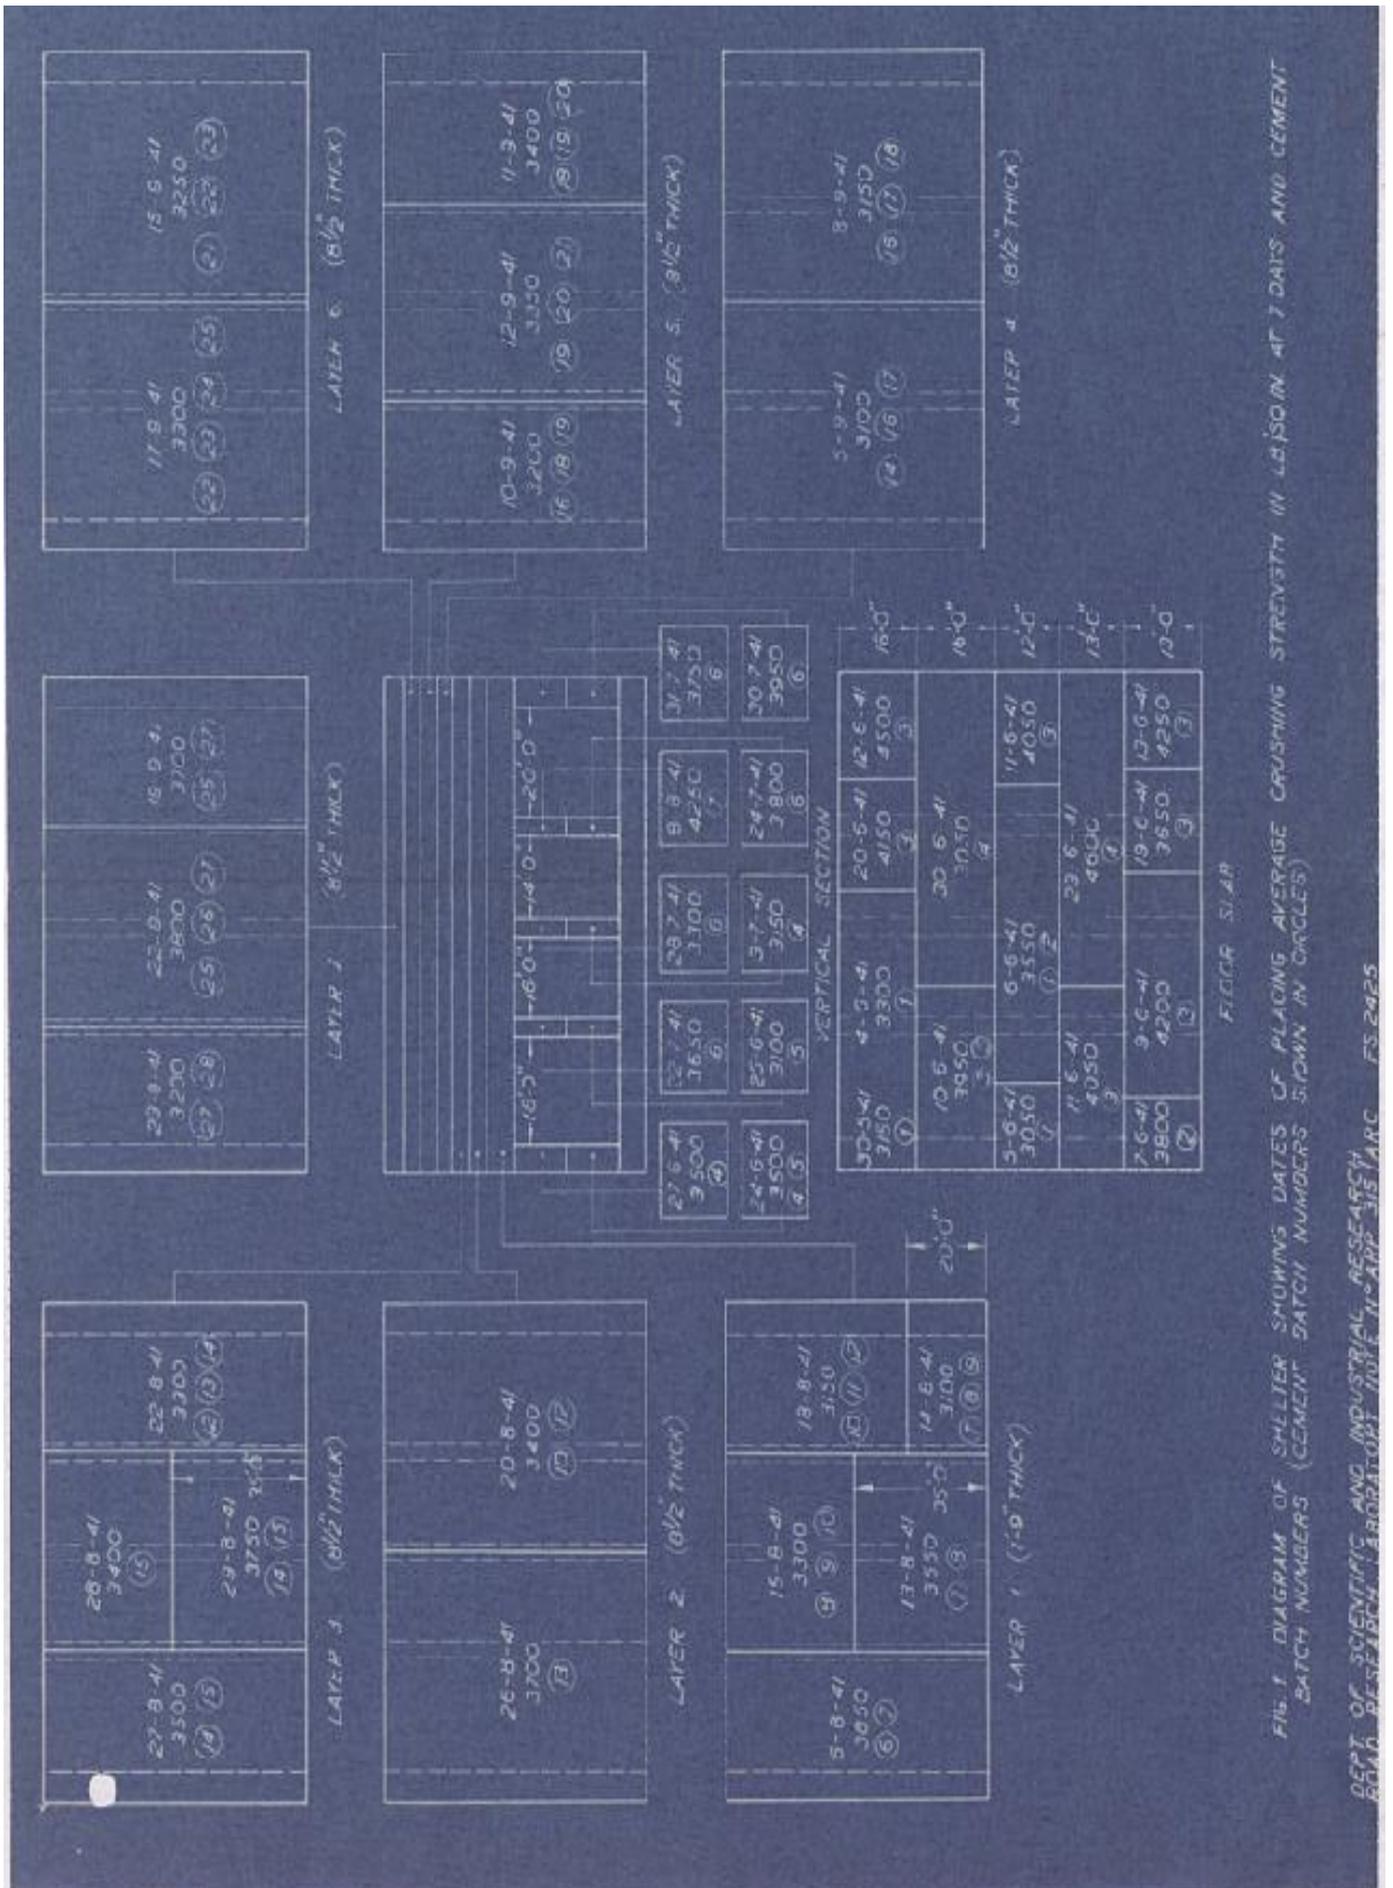
Fig 7 Plans and Elevations of target showing layers of concrete and test results and the date poured

Samples were taken from each 'lift' at the time of pour and tested after seven days. **Fig 7** is a plan and elevation of the target showing the positions of each pour and the crushing strength of the concrete after seven days. The average crushing strength was 3450 lbs/sq.in. and at 28 days 4650 lbs/sq.in. rising to 6580 lbs/sq.in after 3 months. The standard at the time as quoted in ARP Handbook No 5 was 3200 lbs/sq.in. after 28 days. These results compare favourably with today's standards and the concrete was of a very high standard

FIG. 1 DIAGRAM OF SHELTER SHOWING DATES OF PLACING AVERAGE CRUSHING STRENGTH IN LB/SQ IN AT 7 DAYS AND CEMENT BATCH NUMBERS (CEMENT BATCH NUMBERS SHOWN IN CIRCLES)

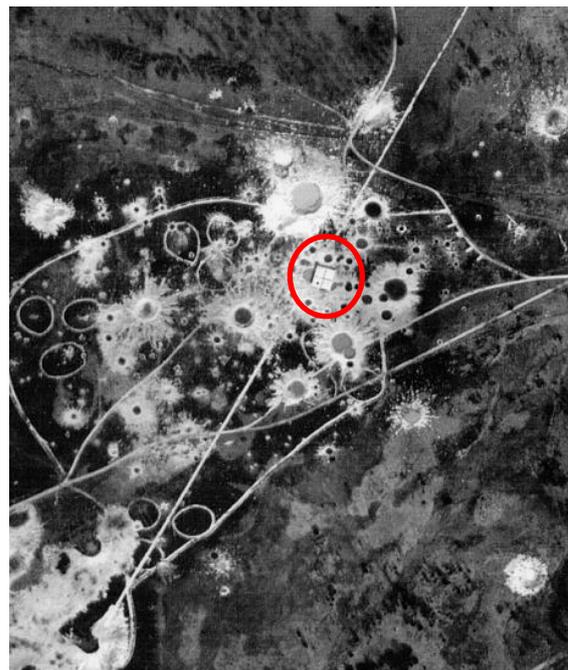
The trials that took place are listed below. As insufficient German bombs were available for the trials and modifications would have been necessary to aircraft bomb release gear, inert equivalent British bombs were dropped to form impact craters. German bombs were to be placed in these craters and fired electrically. It is not known how many attempts were made to achieve the required number of hits of the target but it was probably substantial considering the USAAF Flying Fortress took 28 attempts to achieve 3 hits. **Fig 8** shows the 'sub pens' (circled in red) surrounded by craters in 1947.

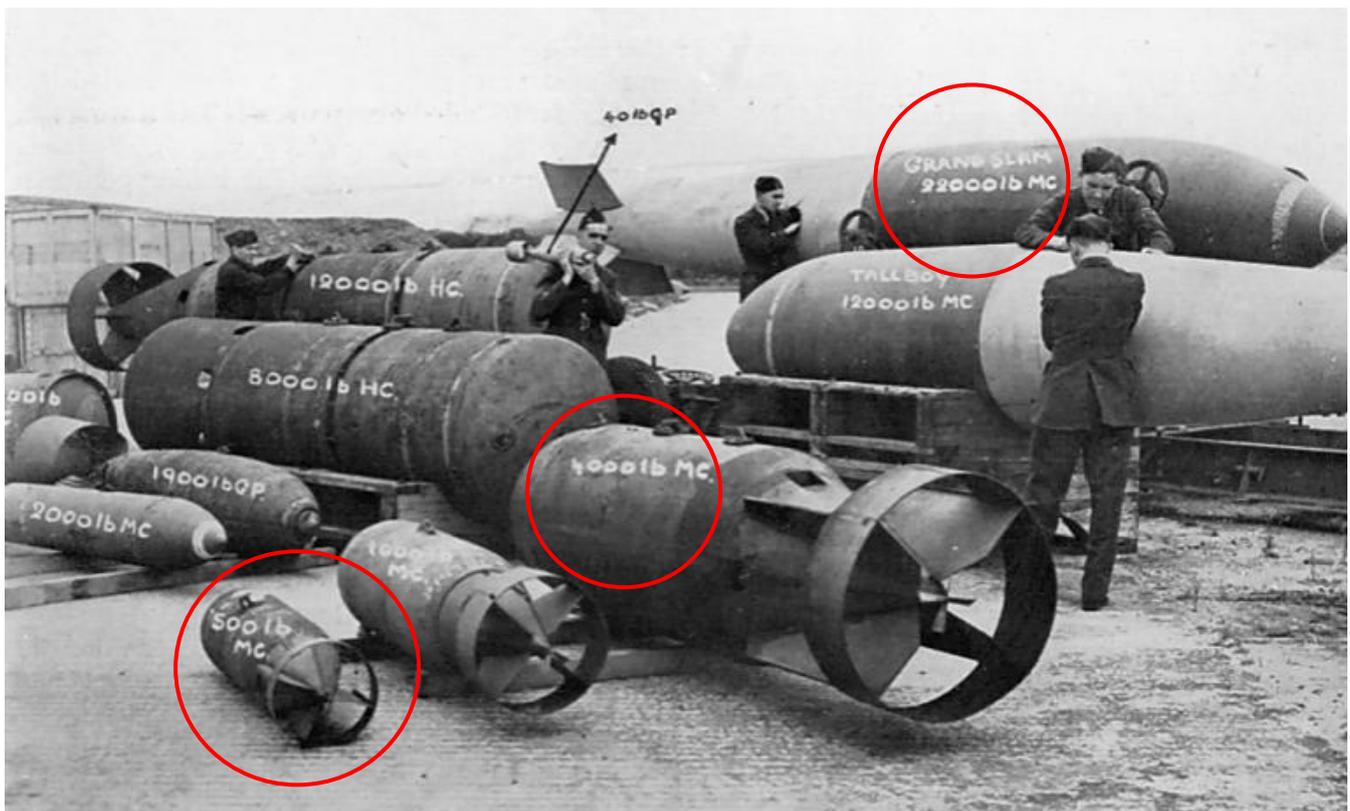
Fig 9 Size comparison of various RAF bombs . The weapons circled in red are discussed in this report

Fig 9 shows a selection of standard British bombs. The 500lb MC bomb is on the bottom left.

There was a need for a 4000lb bomb that could be dropped with accuracy and the 4000lb MC bomb was developed from the HC version. The design brief was that the bomb should be capable of being dropped from low heights and withstand impact against metalled roads and concrete structures – in fact these were to be early 'bunker busters.' The tests at Ashley Walk are the first known live tests of these bombs (See **Fig 9** for a photograph of this type of bomb.)

No further tests are known to have taken place although the 10 ton Grand Slam Bomb was dropped near the target in March 1945. This huge bomb is also shown in **Fig 9**.

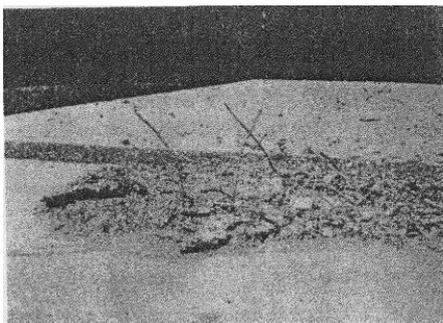
**Bomb No 1:** This was a British 500lb GP Mk IV bomb filled with TNT and fused 1/10<sup>th</sup> sec nose and 1/40<sup>th</sup> tail dropped from 12000 feet at an air speed of 200 mph. The bomb hit the target at about 18 feet from the unsupported west edge of the roof slab and approximately at the centre of the span of the 14 foot bay

**Fig 11: Bomb Crater showing reinforcing bars bent up**

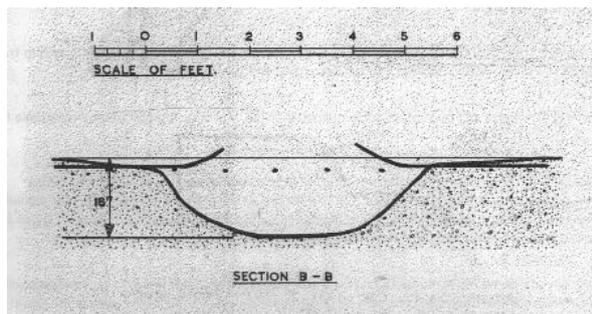
**Fig 12: Section through the crater.**

The maximum depth of the crater was 18 inches. The bottom was flat suggesting the bomb stripped the concrete at a construction joint. Gauges within the shelter showed an elastic deflection of  $\frac{3}{4}$ " but no distortion of the soffit plates.

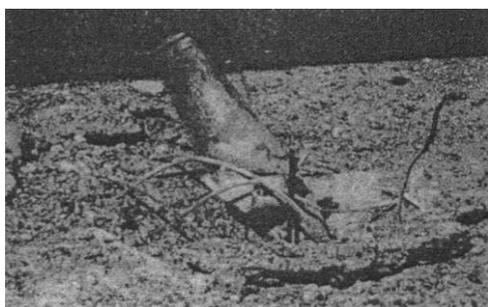
**Bomb No 2:** This was a British 500lb SAP Mk V bomb filled with a suitable high explosive substitute by the Royal Ordnance Factory Woolwich. It was dropped from 12000 feet at an air speed of 200 mph. It hit the target at about 15 feet from the west edge and 6 feet from the north edge of the roof slab. The point of impact was within the clear span of the 20 foot bay at about 2ft 9in from the inner face of the 3ft 3in thick supporting wall. The bomb showed no outward sign of damage.

**Fig 13: Bomb still in position after impact**

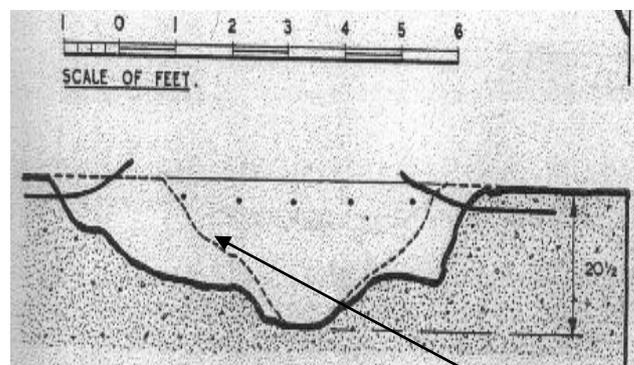
**Fig 14: Section through the impact crater, The dotted line is the crater formed by the impact of the inert bomb. There was no apparent damage to the underside of the slab and no deflection measured**

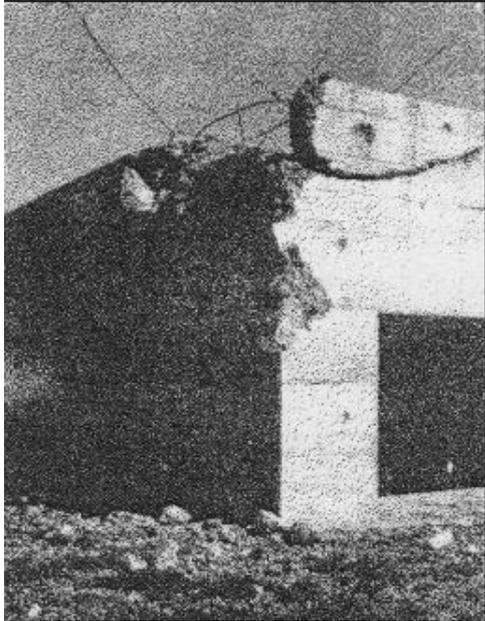
**Bomb No 3:** This was similar to bomb No 2 being an inert 500lb British SAP Mk V bomb. It hit the north west corner of the target over the 3ft 3in thick supporting wall and broke away

the concrete down to the level of the intermediate layer of slab reinforcement 2ft 6in below the top surface. The bomb bounced off and buried itself in the earth. At the time of the report it had not been recovered and may still be there!

**Fig 15 Damage to corner of target caused by Bomb No 3**

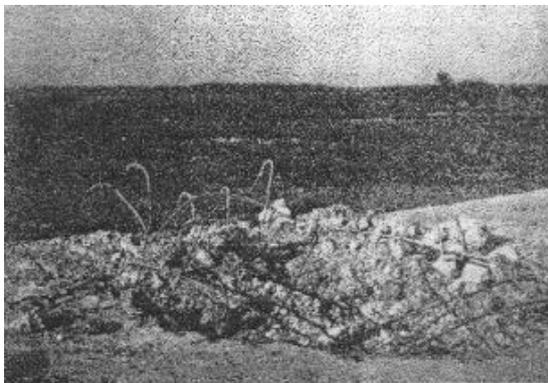
**Bomb No 4:** A German 250kg SC bomb was placed on its nose in the crater formed by bomb No 2. The German bomb was almost identical to the 500lb British bomb although had a slightly heavier charge weight (285lb versus 250lb). Insufficient German bombs were available for actual dropping trials. The bomb was detonated electrically and the crater formed was almost double the size of the crater produced by the inert bomb No 2 but the maximum depth remained unaltered – See **Fig 14**. Some damage was caused by the soffit deflecting. The deflection was beyond the maximum 1 inch measurable by the gauge. The damage caused was greater than the theoretical calculations indicated

**Fig 17 Crater formed after detonation**

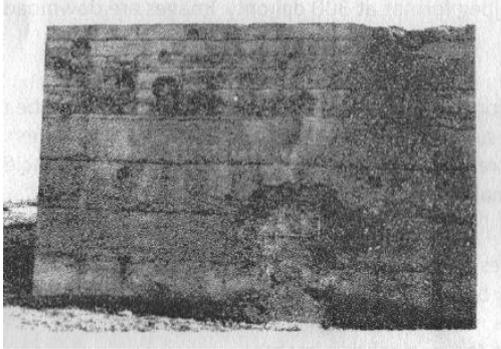
**Bomb No 5:** This was a 50kg (57.2lb charge weight) German bomb placed in a vertical position on the ground with its side in contact with a 3ft 3in thick outside wall. The bomb was detonated electrically. The crater was approximately 4 feet in diameter with a maximum depth of 9 inches. No reinforcing bars were severed. The observed damage was slightly less than expected. However the spall damage to the internal wall was greater than expected. The maximum spall area was 9 feet by 6 feet with the largest scab being 9in x 12in x 4in.

**Fig 18 Bomb crater**

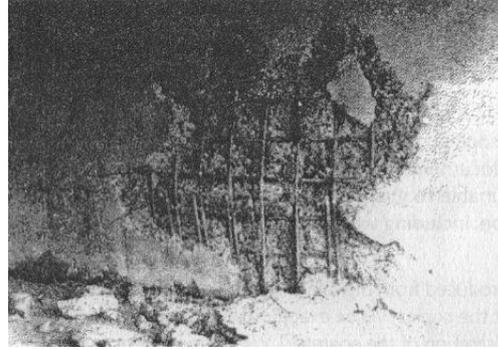
**Fig 19 Spalling of internal wall**

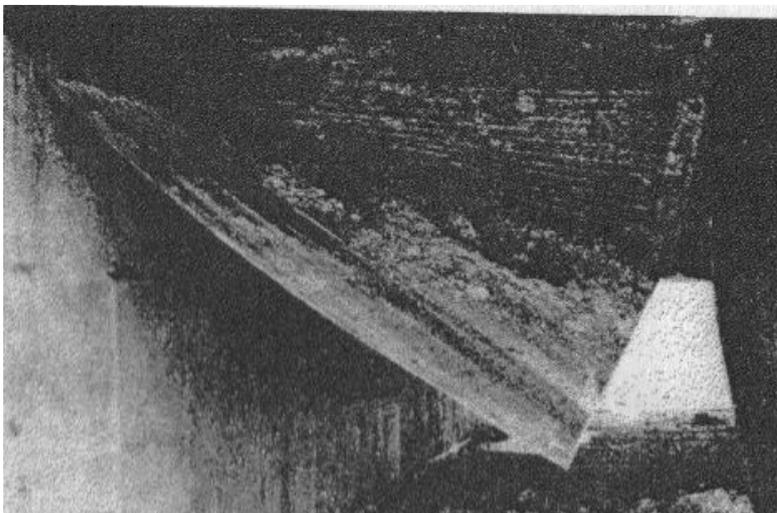
**Bomb No 6:** This test was to ascertain the resistance of the target to the maximum explosive effect of a larger bomb than the British 500lb GP for which the roof was designed. A German 500kg SC bomb was placed on its side on an undamaged part of the roof slab at the centre of the 18 foot span and 20 feet from the unsupported west edge and detonated electrically. Theoretical calculations indicated that the roof would not be perforated as the slab was 9 inches thicker than calculated for this size of bomb. Perforation did not occur as although the concrete shattered throughout the thickness of the slab, it was held in place by the tension of the reinforcement. The maximum permanent deflection was 31 inches at the centre of the 18 foot clear span of the bay. The crater in the top surface was 11 feet mean diameter and 2 feet 1 inch deep nominally.

**Fig 20 showing internal damage to target. Note the bulge and damaged steel soffit sheet**

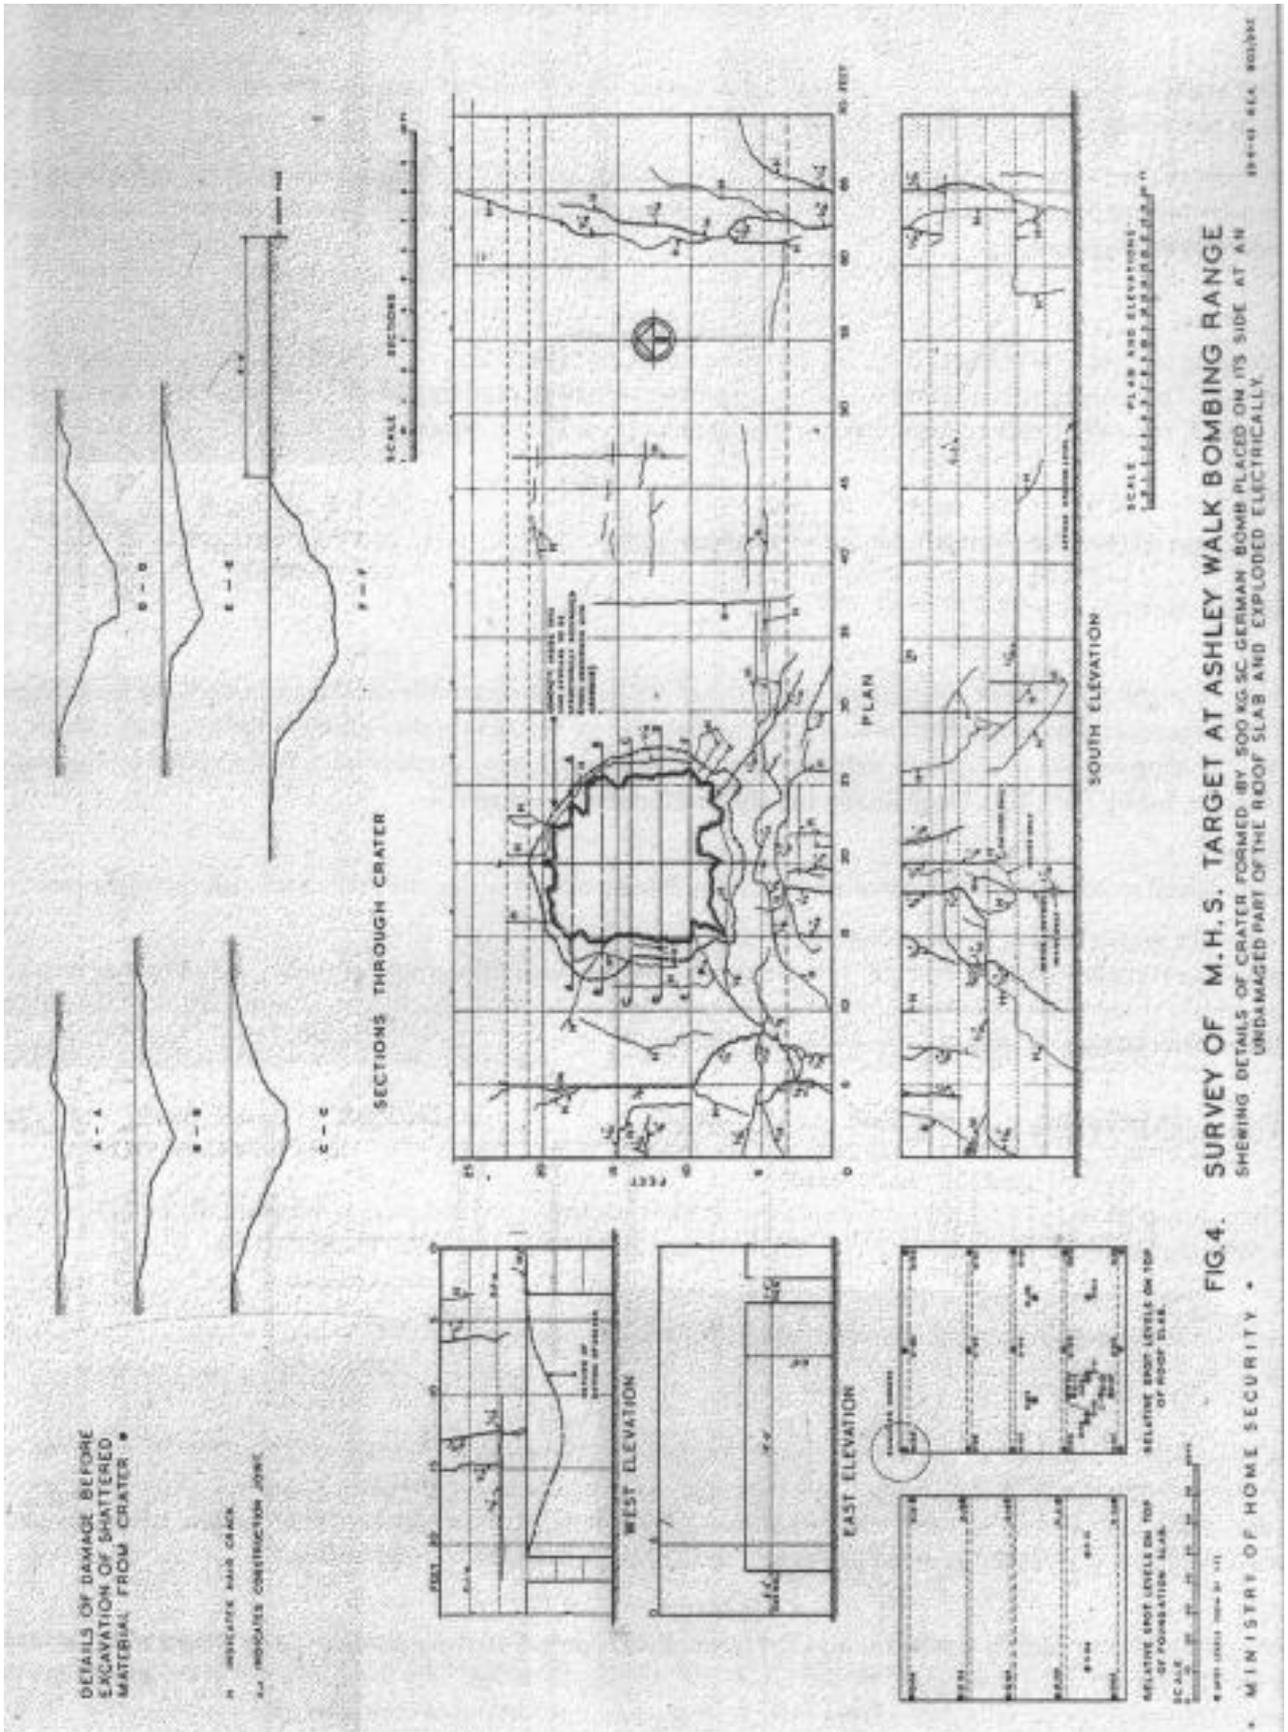
Fig 21 Plans and elevations showing extent of damage caused to the target by Bomb No 6 German 500kg SC bomb

- 1) It was considered sound practice to concentrate the bulk of the steel reinforcement near the inner face
- 2) Some steel was required in the body of the slab (roof) to reduce extensive cracking (Bomb No 6 – see **Fig 21**)

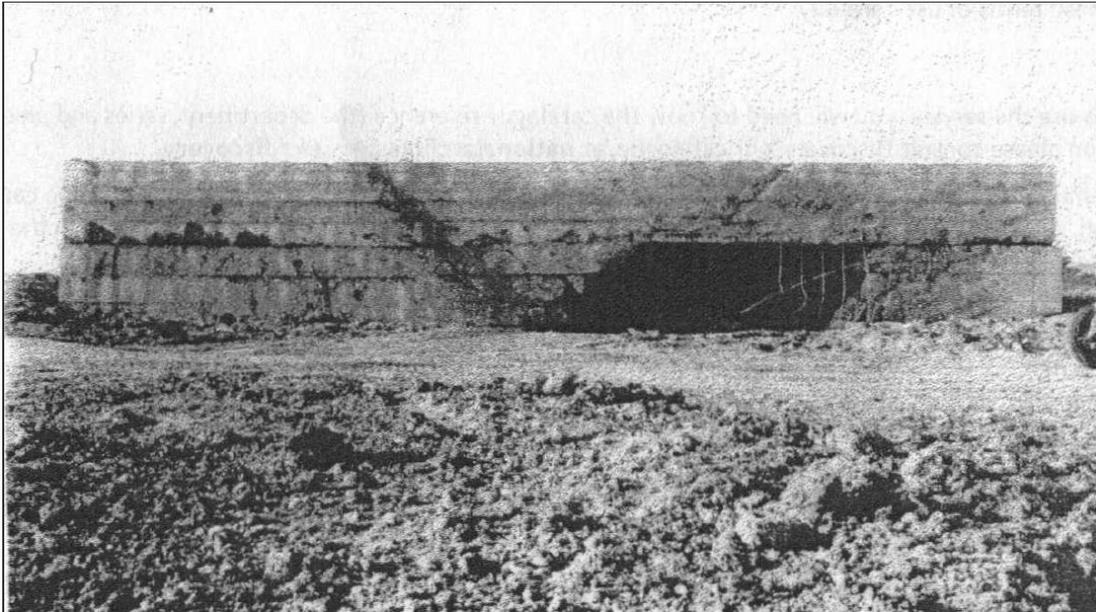
The first bomb (Bomb No 7) was dropped from 5000 feet and struck the ground very close to the south side of the target probably within 2 feet from the 3 foot 3 inch supporting wall. The crater was estimated to be 36 feet diameter by 10 feet deep. It is thought that the bomb detonated when its nose was about 5 feet below ground level. The south wall of the target was demolished up to soffit level for a length of 24 feet. The ends of the standing portions of this wall were moved. There was considerable cracking to the roof.

The floor damage could not be assessed due to the amount of debris from the roof slab

**Fig 22 Damage to target after Bomb No 7 4000lb MC exploded on the ground nearby**

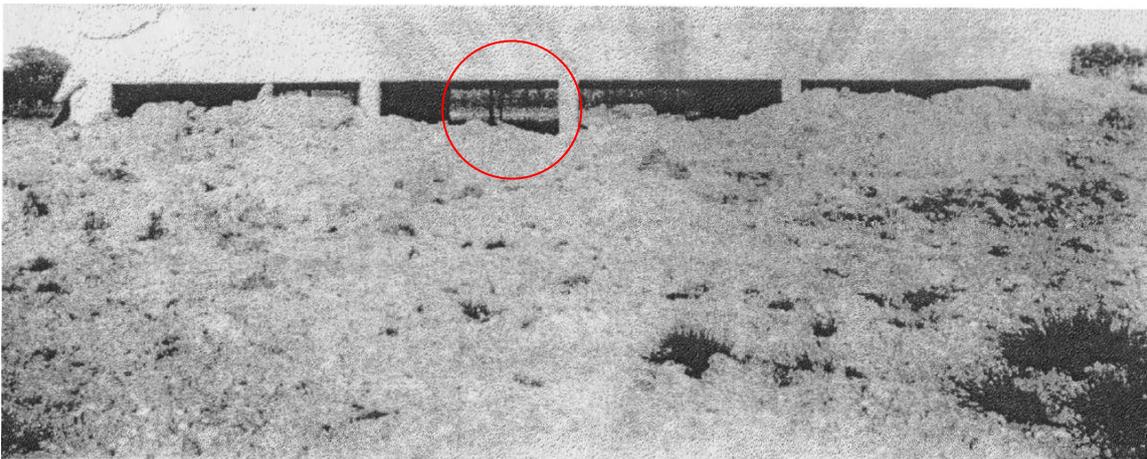
The second bomb (Bomb No 8) was also dropped from 5000 feet and was estimated to have struck the ground about 9 feet from the west side of the target. The crater dimensions were reported as 54 feet diameter and 14 feet deep. The conclusion was that it detonated when its nose was about 10 feet below the surface. The main effect of this bomb was to the floor of the target. In all bays the floor was bowed up at the end nearest the bomb. The maximum being 2 feet 9 inches in the 16 foot bay. A small part of the floor was demolished in this bay.

**Fig 23 Bomb No 8 exploded in the ground about 9 feet from the target. Note the props supporting the roof in bay 2**

It is estimated following these tests that the wall thickness would need to have been increased to 11 feet to avoid this damage and at least to 9 feet to avoid penetration.

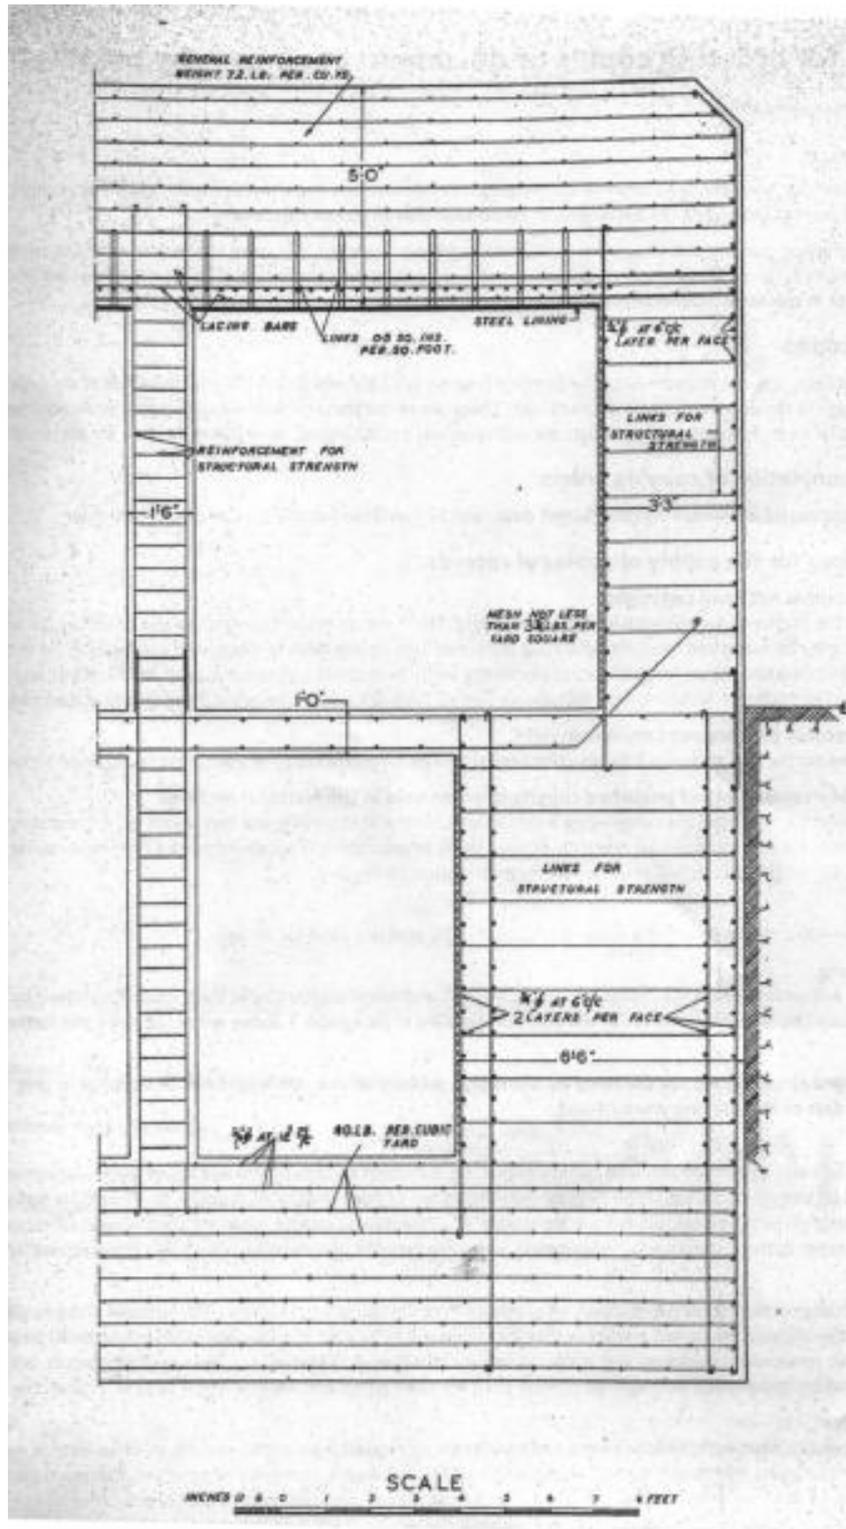
**Fig 24 Reinforcement Detail**

As mentioned earlier the target was built in accordance with the design criteria of Air Raid Precautions Handbook No 5a – Bomb Resistant Shelters - and to give protection classified as Type 3. That is to give adequate protection against 500lb MC bombs striking at maximum velocity. It is interesting to note that the standard construction shown in ARP Handbook 5a has two floors – a ground floor and a basement. It would only have been necessary to construct the above ground part at Ashley Walk as this was the section which was under test.

**Fig 24** to the left is a cross section through a shelter showing both floors. The details are the same as Ashley Walk except that the roof slab is only 5 feet thick instead of 6 feet **Fig 25** on the next page shows plans and elevations for a typical two level shelter for 200 people. Note the airlock and external steps

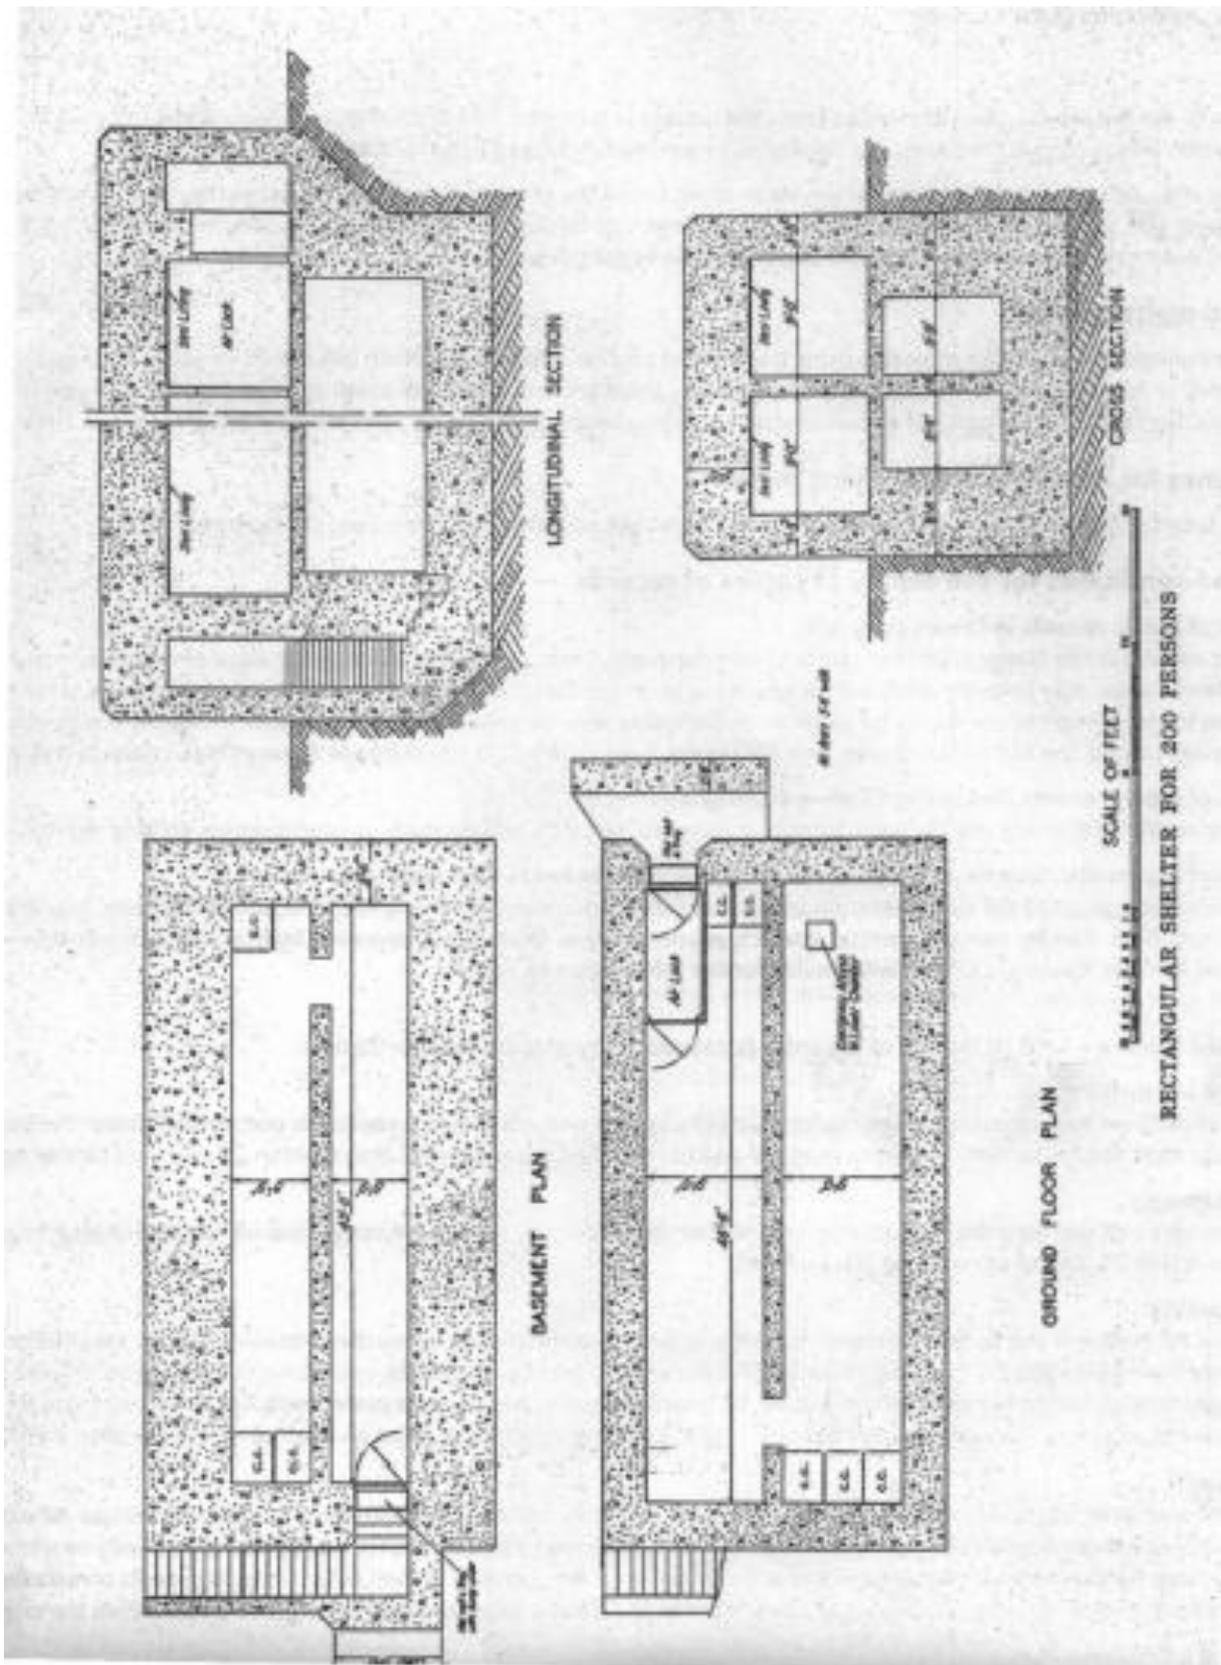
Fig 25 Two level shelter as specified in ARP Handbook No 5. Ashley Walk target was based on the above ground level

As can be seen from the foregoing, the target at Ashley Walk was the above ground section of a two level bomb resistant shelter based on the Ministry of Home Security specifications. It was designed to withstand a direct hit from a 500lb medium capacity bomb. In this it was proved successful and the results came very close to those calculated from the model tests.

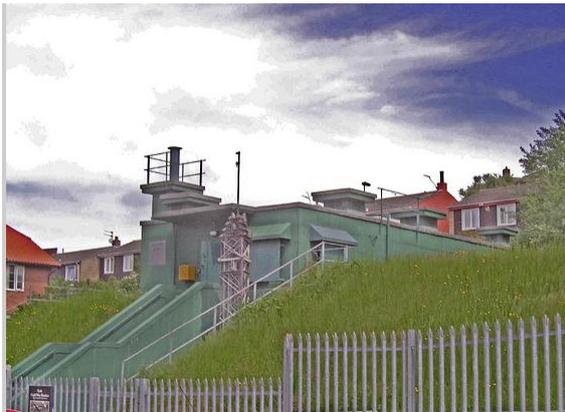
**Fig 26 ROC Group HQ 20 Group York**

War had turned and the threats to the UK civilian population from air attack was reducing. However the legacy of these tests may have passed on to the Cold War period. This two level bomb resistant building will be familiar to those who served in United Kingdom Warning and Monitoring Organisation and Royal Observer Corps during this time as it very similar in design to the 'semi sunk' ROC purpose built Group Headquarters such as the one in York.
