ANDREW WARING
ASSOCIATES

**WW11 SITES IN THE
NEW FOREST NATIONAL PARK AUTHORITY
STRUCTURAL SURVEY REPORTS**

**JOB NO. 6706 – REPORTS
DATE SEPTEMBER 2013**

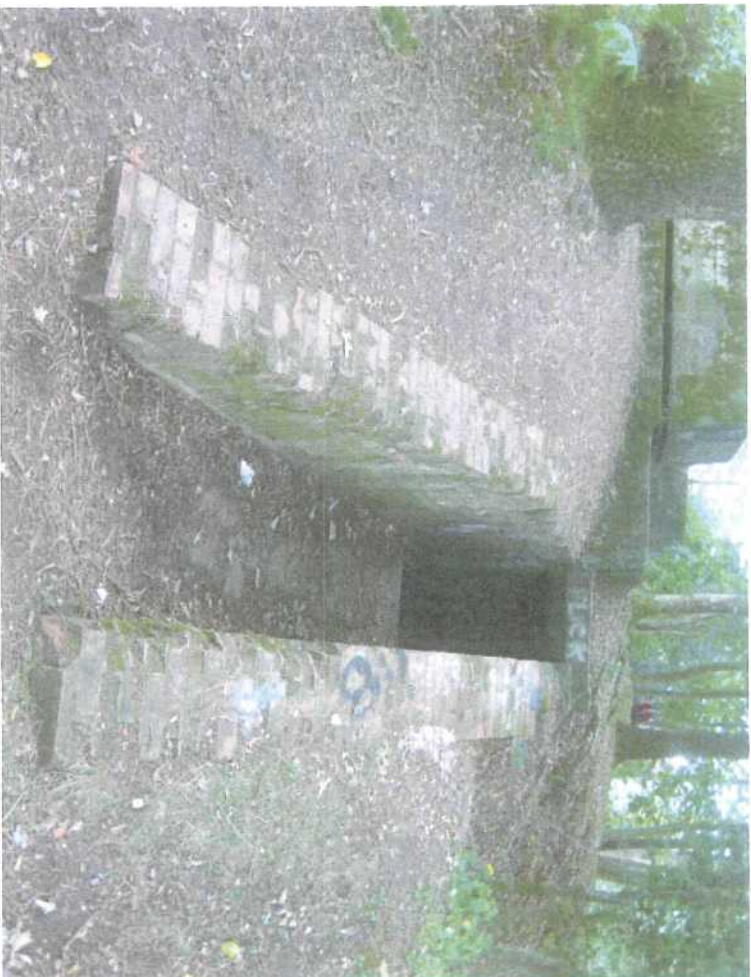
Photo 1

There is an entrance to the bunker from the south side with brick retaining walls to each side and then steps down to the bunker. The brickwork walls are in excellent order with no significant defects. The concrete steps run under a shaped lintel and underground to the main entry point.

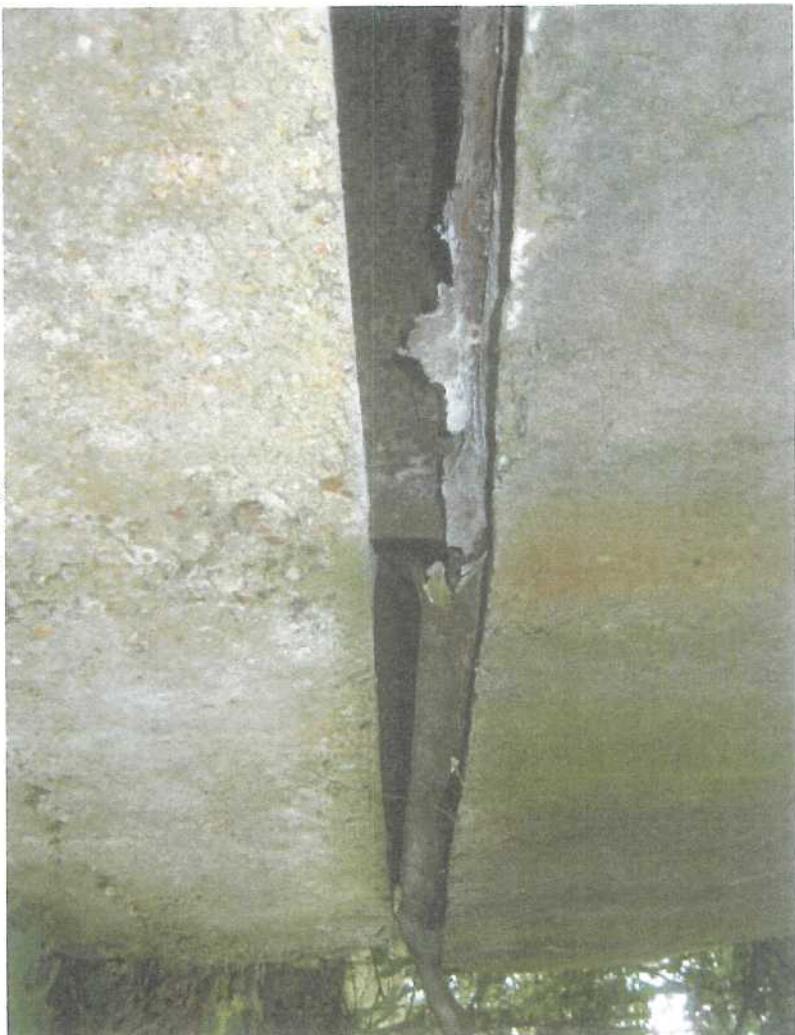
Photo 3

The southern turret and exposed roof are of concrete with a thin render skim. This render has been lost in a number of areas. The vision slit shows vestiges of a metal flashing but its form and purpose are now unclear. (photos 3 and 4). The concrete shows no undue sign of distress (photo 5).

Investigate further external waterproofing render and repair/reinstate

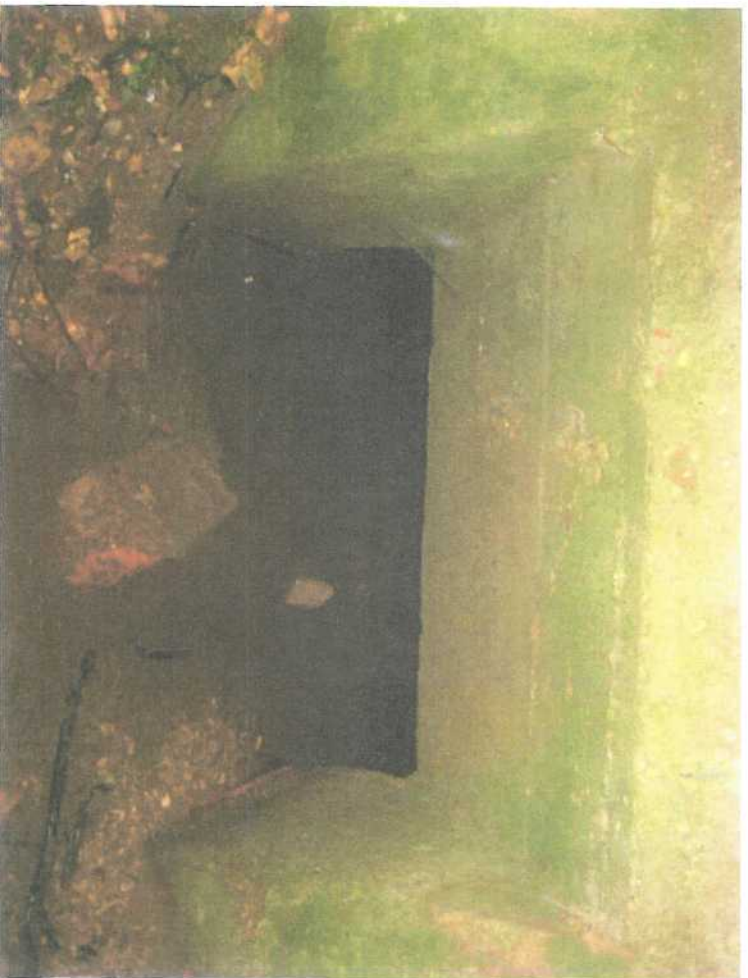
Photo 4

There are two entry doorways to chambers off the access chamber. Each is at lower level and with a tapered in-situ lintel. The main chamber is filled and there is water at about 200mm below the access door lintel rendering inspection almost impossible (photo 4). Using torch and camera, it was possible to establish that the walls are of brick and the roof slab is of reinforced concrete with boarded soffit finish (photos 5 and 6). Beyond that, meaningful inspection was not possible.
